# Metro Portland'5 Centers for the Arts

Facility Condition Assessment for  
Antoinette Hatfield Hall

April 10, 2026 | Prepared by: Sazän Group

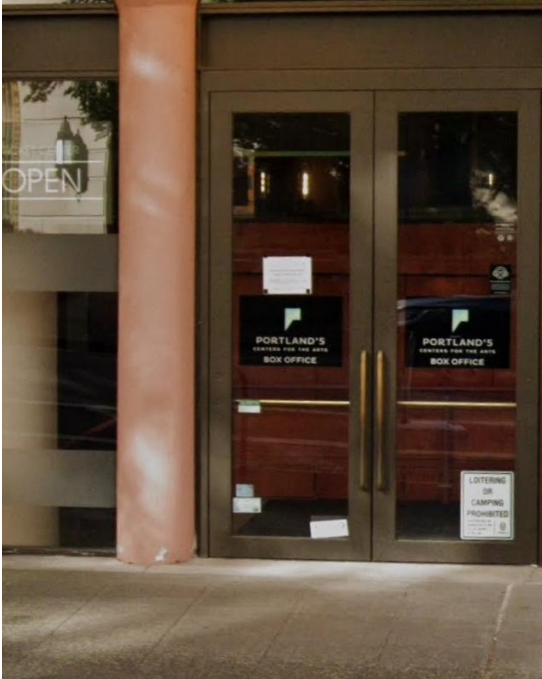
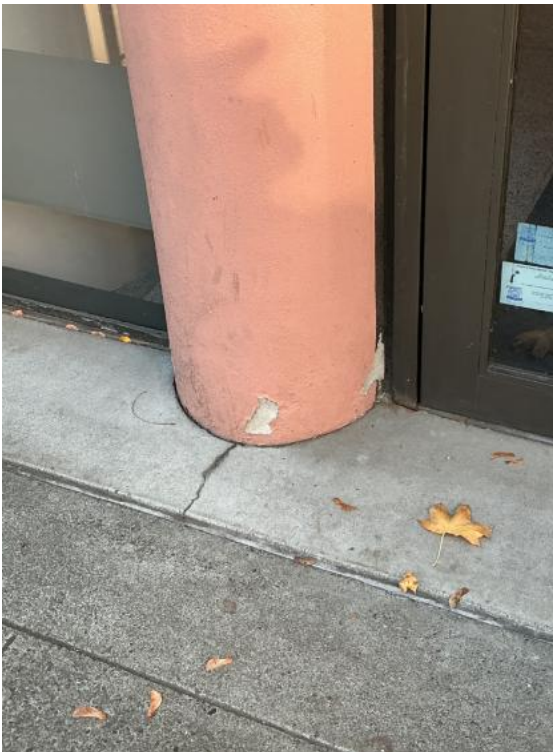
#### Additional Evaluation Needed: Column Foundations & Pile Caps

A1112 Column Foundations & Pile Caps

Degree and extent of degradation should be investigated by a qualified agency or contractor, and repaired as required to restore structural capacity of damaged elements and mitigate corrosion of reinforcement. Likewise source of water intrusion needs to be identified and addressed to ensure it does not continue to occur. Cost reflects price of evaluation only. Further findings from evaluation and recommendations by structural and/or construction contractor may result in additional costs with corrective actions.

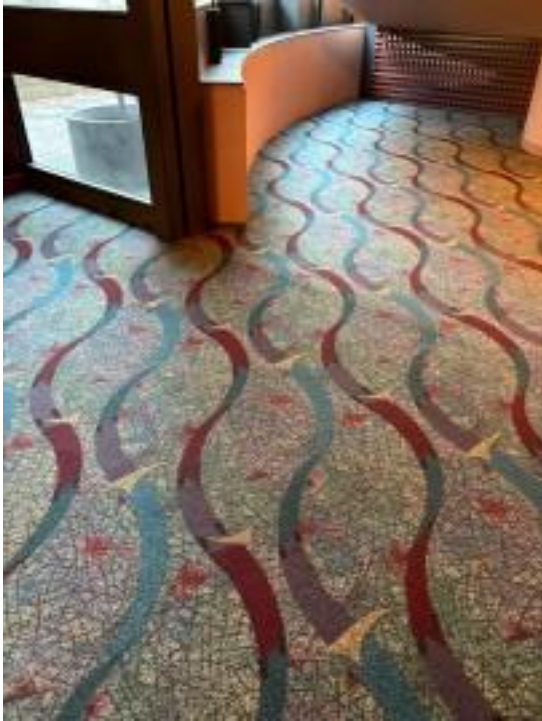
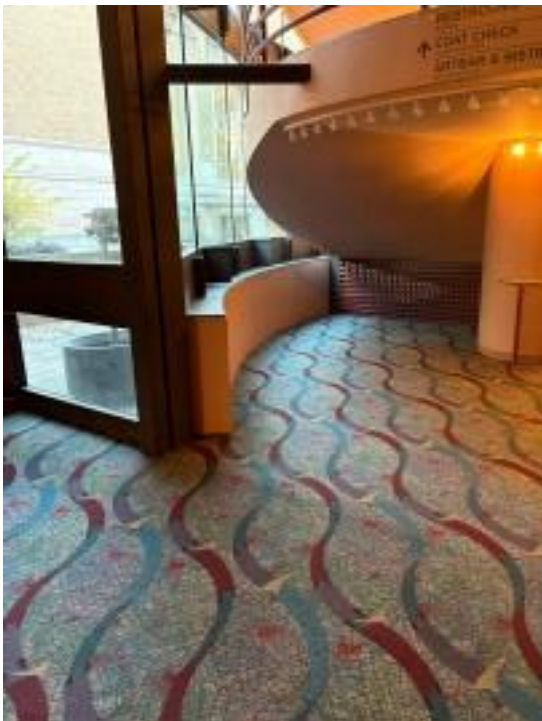
## Additional Evaluation Needed: Standard Slab on Grade

A1331 Standard Slab on Grade

Slab should be exposed and investigated by a qualified contractor to determine source of settlement and extents. Options for remediation include demolishing existing slab, preparing subgrade, and recasting it, or leveling it via pressure grouting or similar method.

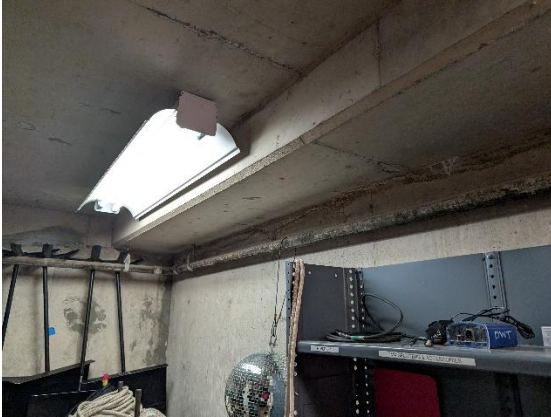
## Additional Evaluation Needed: Moisture Protection

A2222 Moisture Protection

Engage a qualified professional to investigate leak path, generate scope documents, and oversee basement waterproofing.

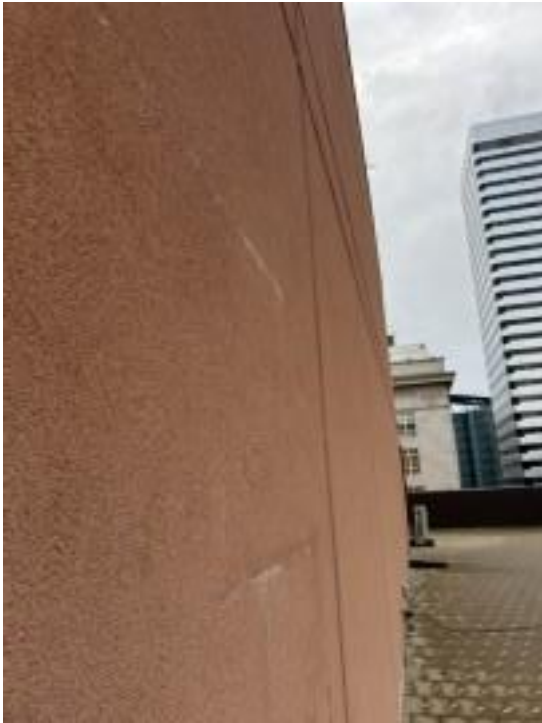
## End of Useful Life: Exterior Wall Construction

B2111 Exterior Wall Construction

Perform targeted repairs to address deficient materials. Repair roof/gutter system prior to repairs before routing cracks ( $>1/16"$ ) then sealing with elastomeric coating.

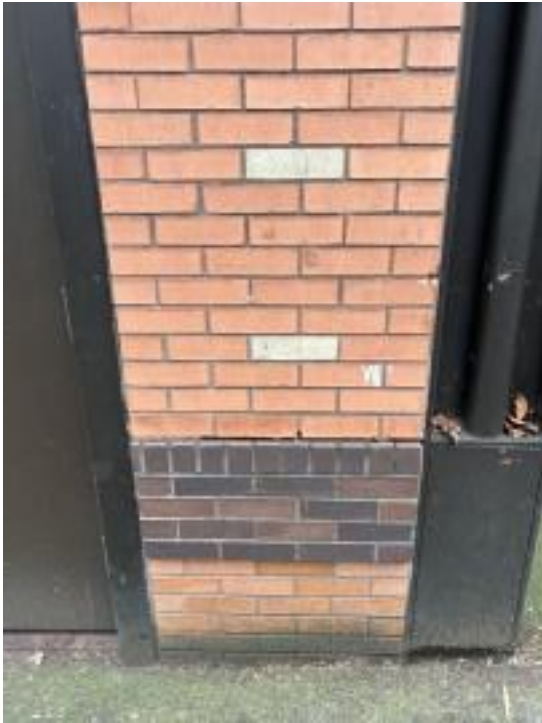
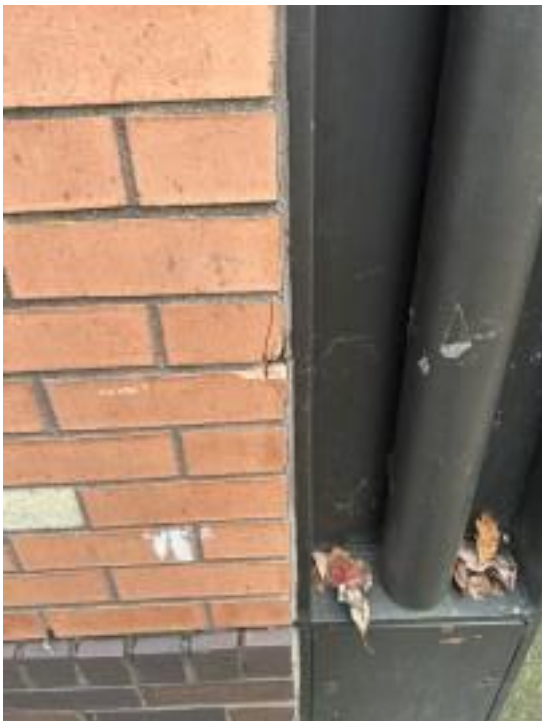
## End of Useful Life: Exterior Wall Construction

B2111 Exterior Wall Construction

Targeted repair to address cracked brick.

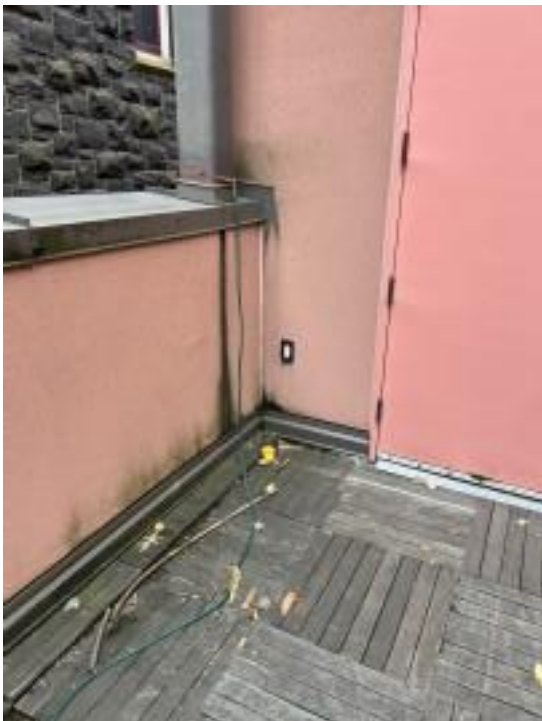
## End of Useful Life: Parapets

Organic growth accumulation and failed sealant joints.

Repair and maintenance campaign to clean surfaces and repair failed sealant joints associated with this component number.

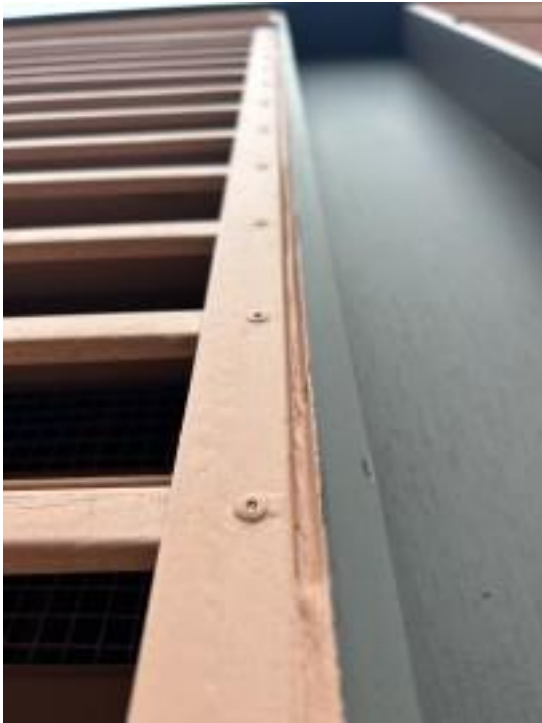
## End of Useful Life: Exterior Louvers, Screens and Fencing

B2113 Exterior Louvers, Screens and Fencing

Cut out and replace material with polyurethane based sealant and backer rod for 10-20 year useful life. Can be extended to 20-30 years by using premium silicone sealant (price not included in estimate).

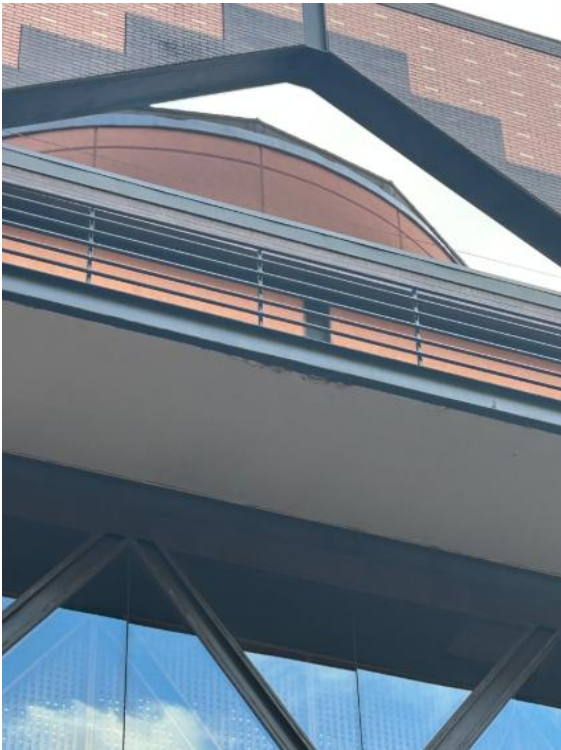
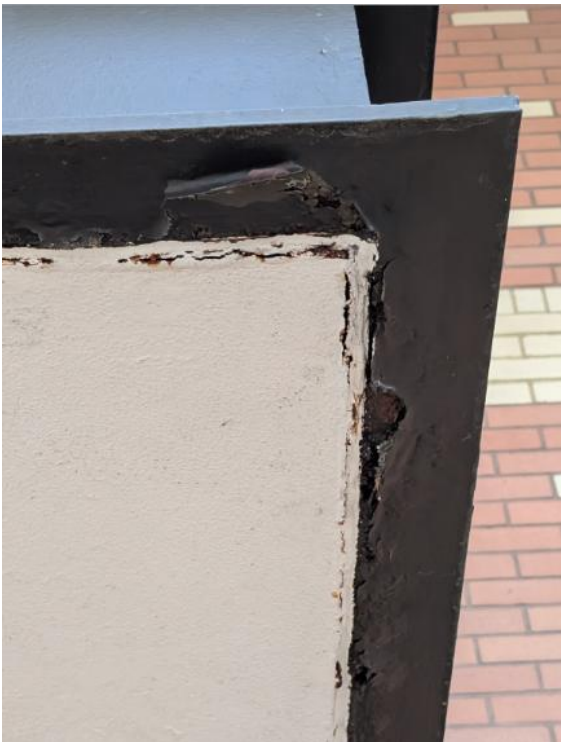
Major Maintenance: Exterior Soffits

B2116 Exterior Soffits

Patch and repair cracked stucco soffits; seal joints/cracks; prep and repaint with exterior-grade coating system.

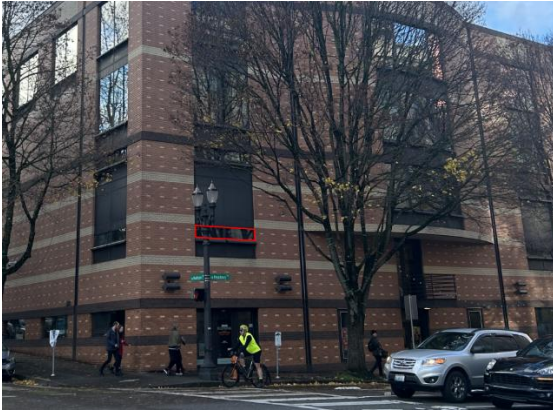
## End of Useful Life: Exterior Windows

B2221 Exterior Windows

Replace sealant joints associated with this component number and utilized standardized detailing for targeted repairs of windows.

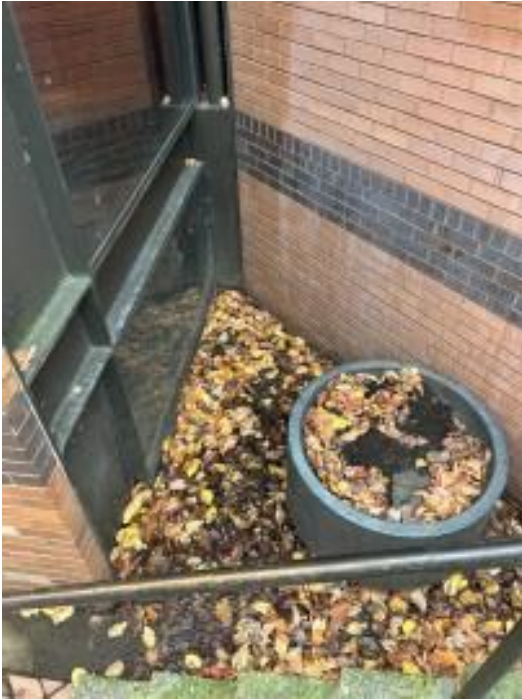
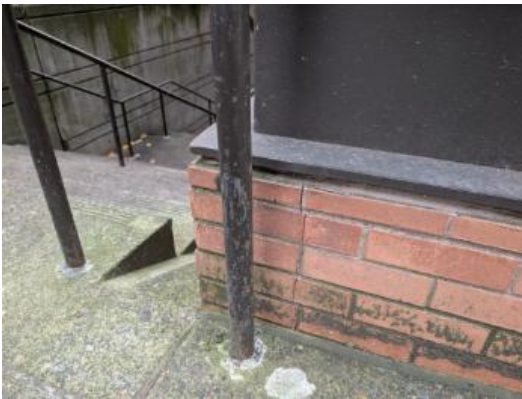
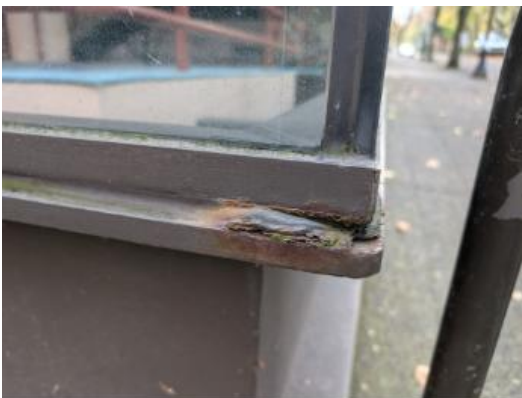
## End of Useful Life: Exterior Curtain Walls

Active water intrusion and evidence of frequent water intrusion throughout the curtain walls. Configuration at northwest curtain wall prevents proper drainage.

Replace sealants associated with this component number. Coat area of reentrant corners with PUMA, install drain (if possible), and slope away from structure to address improper drainage. Redo base of wall transitions during PUMA traffic coating application.

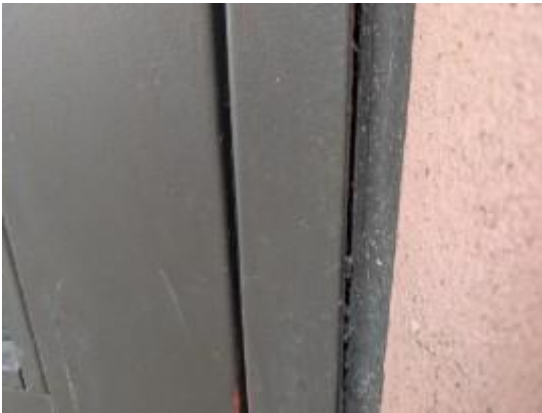
## End of Useful Life: Exterior Storefronts

Sealants for storefront windows and door jambs have reached end of useful life.

Remove and replace sealant joints associated with this component number.

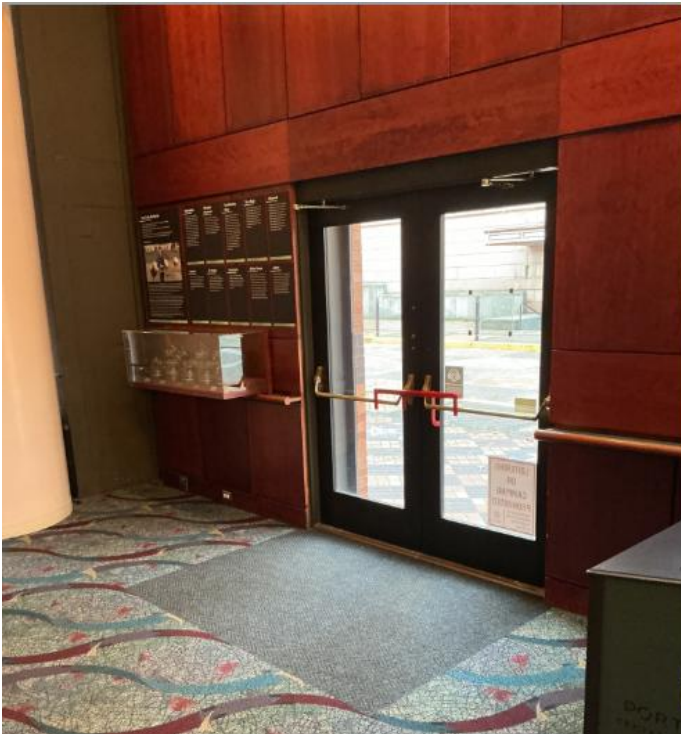
## Major Maintenance: Exterior Glazed Doors & Entrances

B2331 Exterior Glazed Doors & Entrances

Repair/replace door thresholds and sills; install/repair pan flashing as needed; replace weatherstripping and adjust doors to prevent water infiltration.

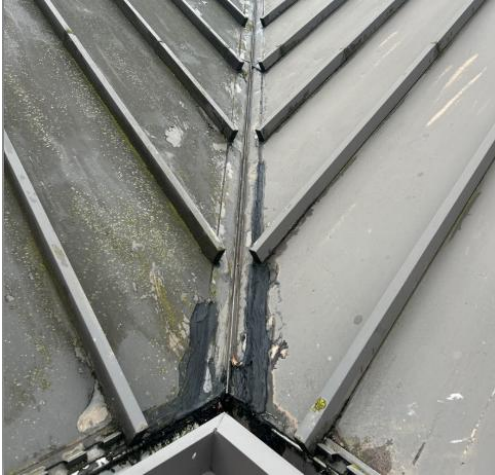
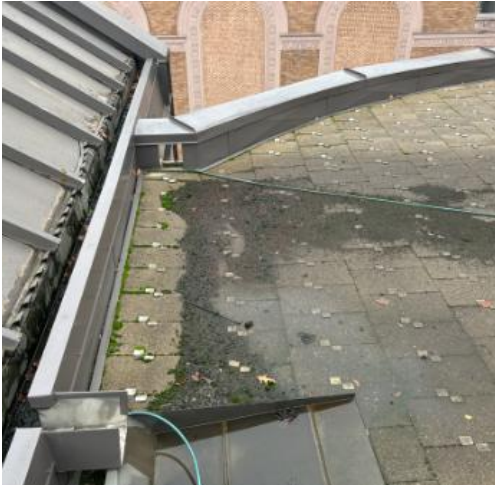
## Major Maintenance: Roof Finishes

B3111 Roof Finishes

Repair roof finish defects including failed sealant joints and localized membrane/metal repairs; clean and restore drainage.

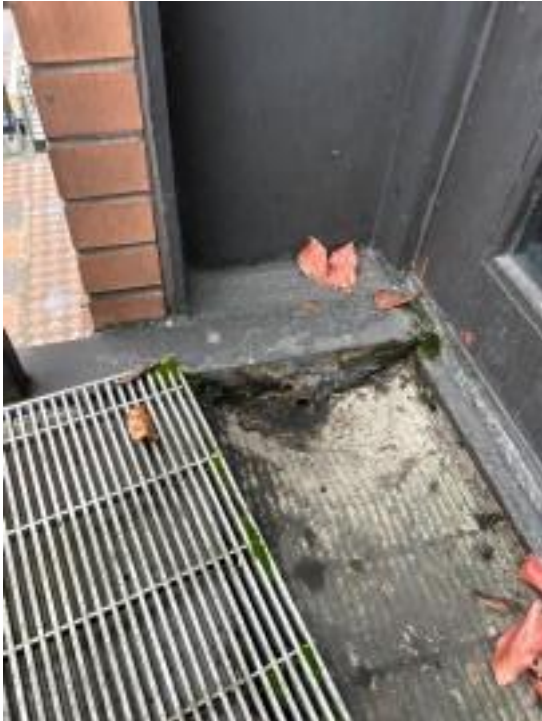
## End of Useful Life: Balcony Walls & Handrails

B3112 Traffic, Toppings & Paving  
Membranes

Replace deck coatings with pedestrian traffic coating (e.g. polyurethane methacrylate (PUMA) for 20 year life cycle or Polymethyl methacrylate (PMMA) for 5-10 year life cycle). Plan for regular maintenance (e.g. cleaning surfaces and drainage systems) on a seasonal basis. Monitor drains on a weekly or biweekly basis to ensure clear path for water flow. Utilize manufacturer recommended cleaning products to ensure life of material. Price is based on PMMA coating.

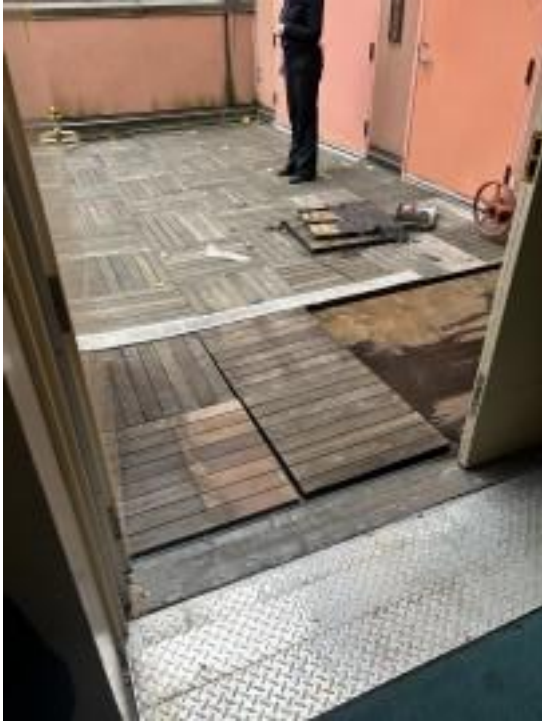
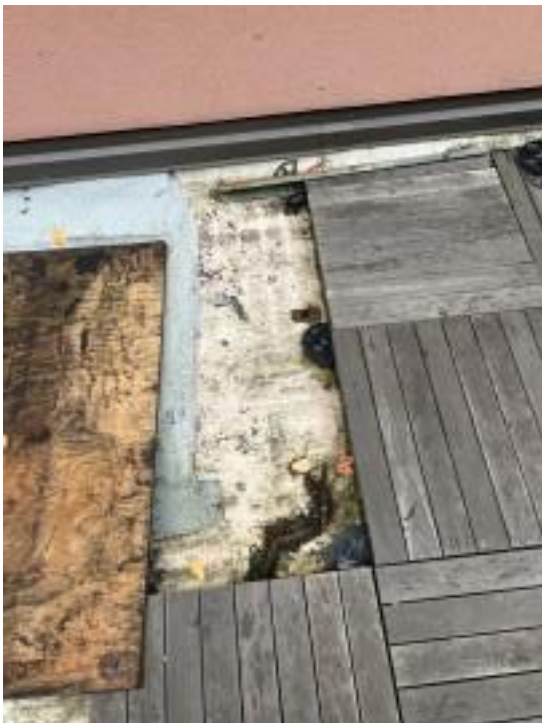
## Major Maintenance: Traffic, Toppings & Paving Membranes

B3112 Traffic, Toppings & Paving  
Membranes

We recommend replacing roofing with  
continuously supported precast concrete pavers,  
to match the character of the mid height roof,  
over thermoplastic polyolefin (TPO) membrane.  
Close attention to roof transitions and drainage  
is required due to history of reported leaks. Price  
reflects replacement of membrane and pavers.

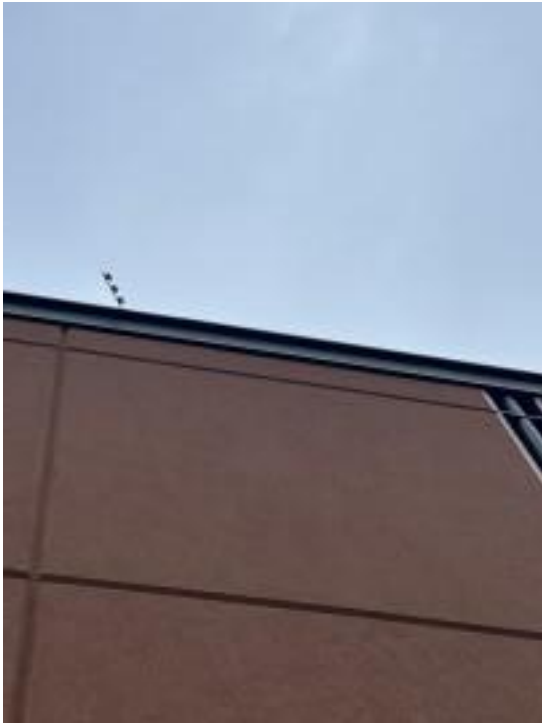
## Life Safety and Code Violation: Flashings & Trim

B3114 Flashings & Trim

Secure loose diverter flashing to prevent it from dislodging completely and falling.

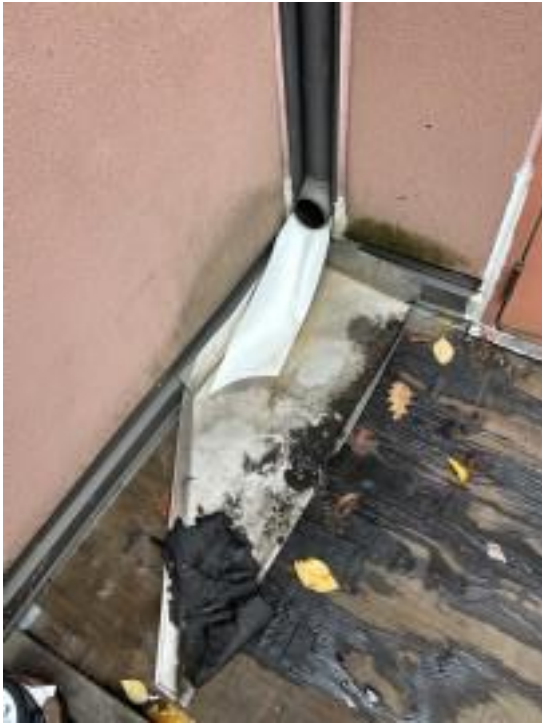
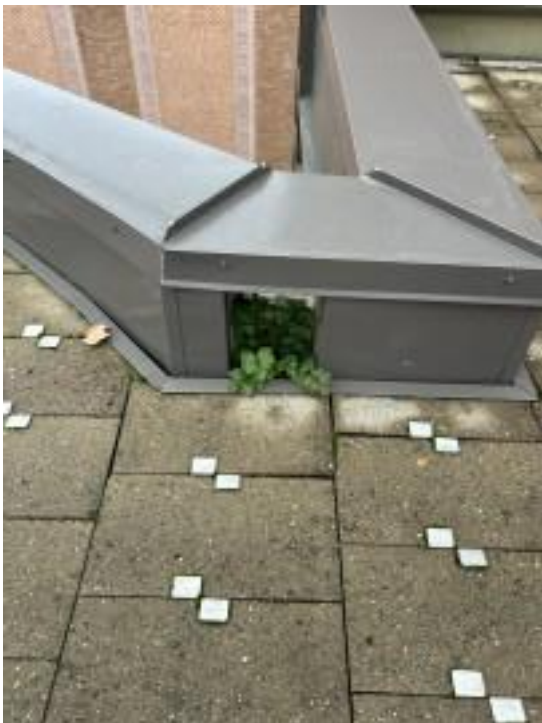
## Additional Evaluation Needed: Gutters and Downspouts

B3116 Gutters and Downspouts

Engage a consultant to verify source of leaks, prepare ROM pricing, and oversee contractor selection/performance. Clean all scuppers.

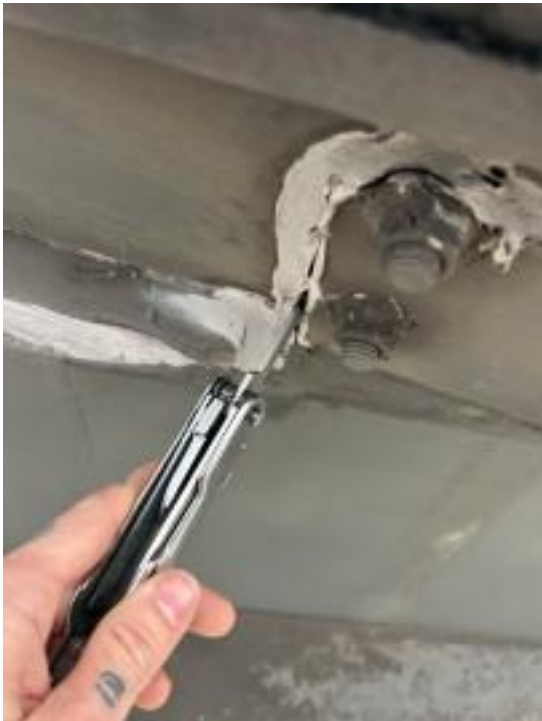
## Additional Evaluation Needed: Glazed Roof Openings

Evidence of active or recent water intrusion observed along an identified leak path during site walk.

Further evaluation is recommended to determine if rotunda assembly sealant is at end of useful life. For now, remove existing sealant and replace with a wet sealant to prevent further water intrusion. Price reflects cost of evaluation only.

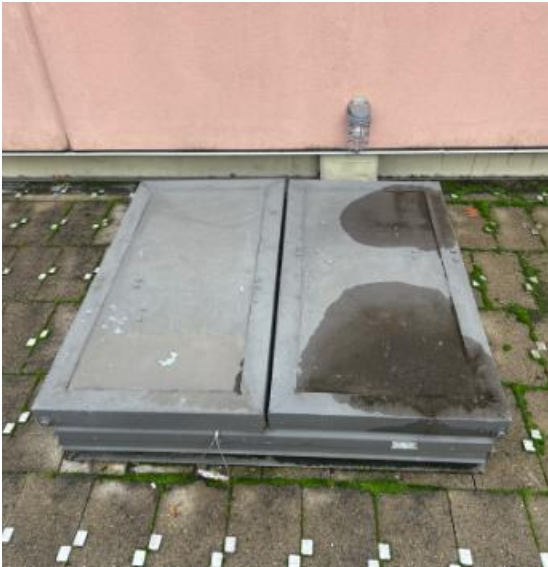
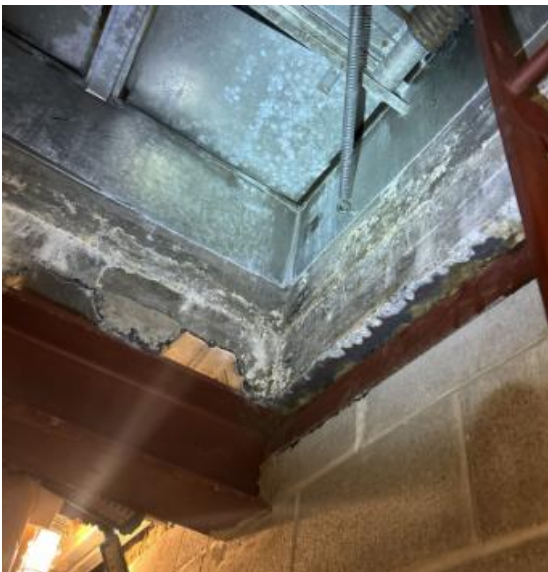
## Major Maintenance: Roof Hatches

Evidence of water intrusion observed at roof hatches.

Replace roof hatch gaskets/seals; repair corrosion and flashing at curb; confirm watertight installation.

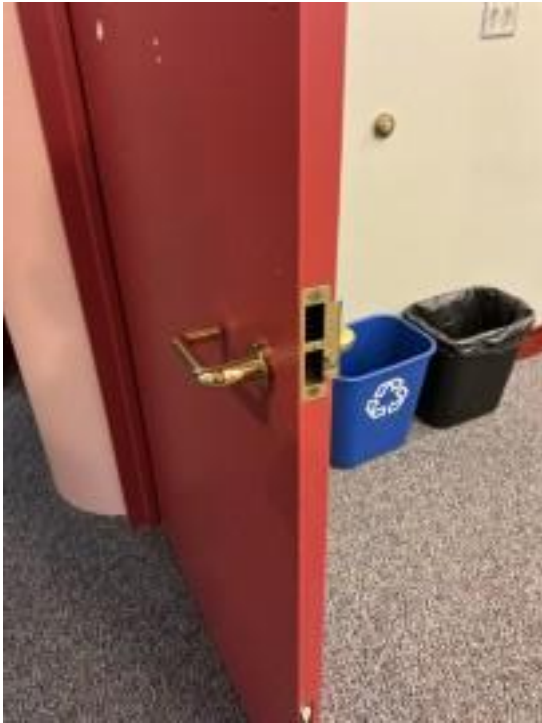
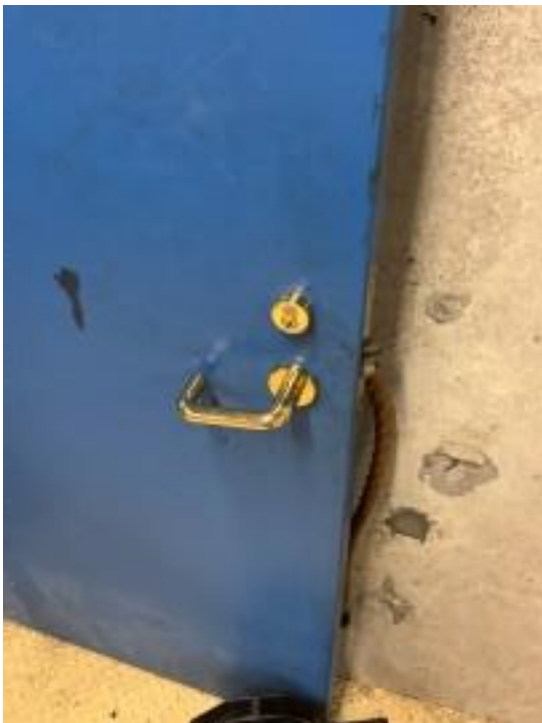
## End of Useful Life: Interior Door Hardware

Interior door hardware assemblies (levers, locksets, and latches) throughout Hatfield Hall show signs of advanced wear and finish degradation. Several components are no longer supported or manufactured, requiring Metro's Engineering team to salvage functional parts from non-operational doors to keep others in service. Hardware is past its typical useful life and increasingly difficult to maintain.

Replace interior door hardware assemblies with new, code-compliant commercial-grade hardware compatible with the existing door/frame conditions. Standardize hardware types facility-wide to allow consistent maintenance and future part availability.

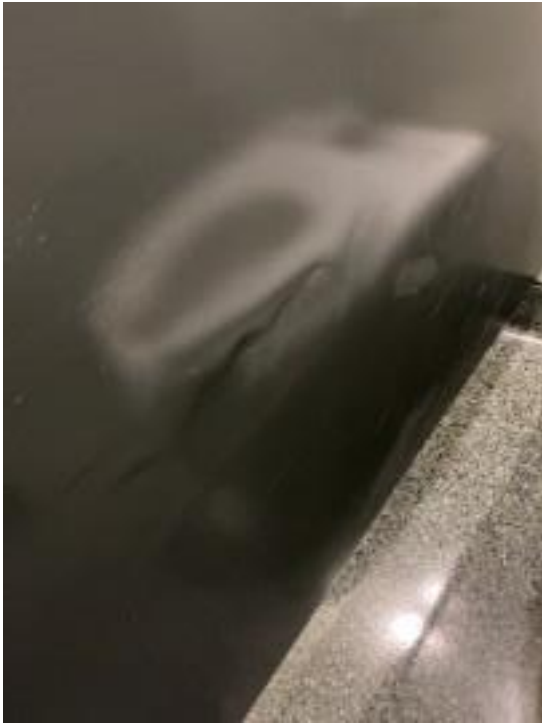
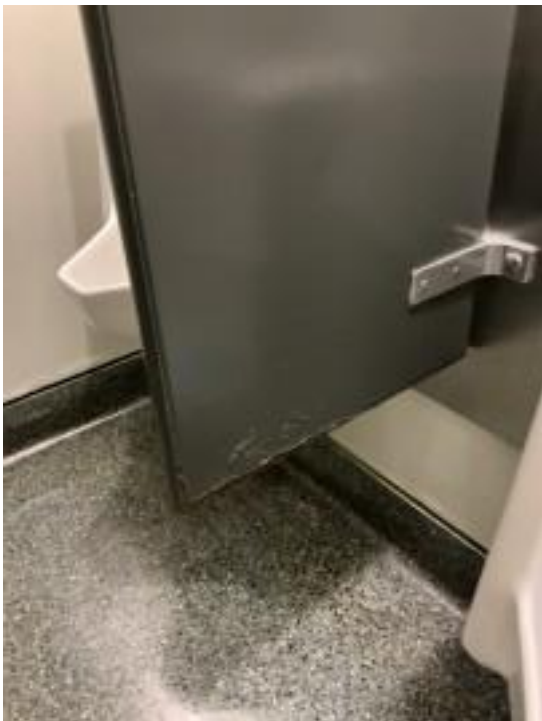
## End of Useful Life: Fabricated Toilet partitions

C1331 Fabricated Toilet partitions

Replace toilet partitions and urinal screens with new commercial-grade, corrosion-resistant systems.

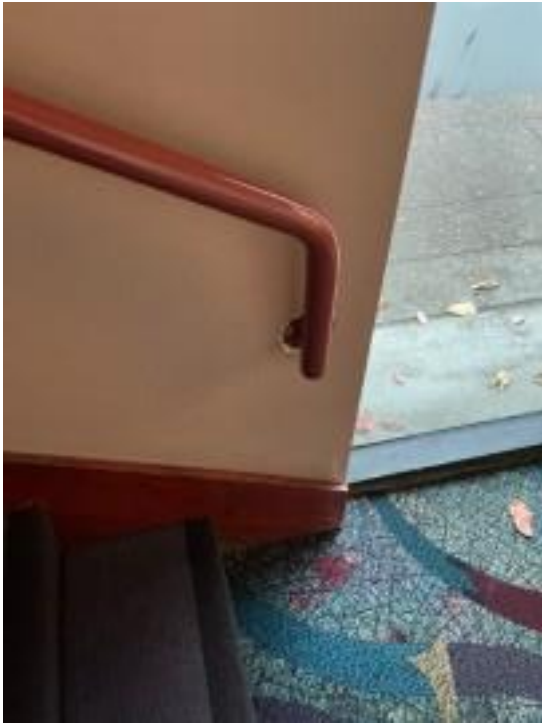
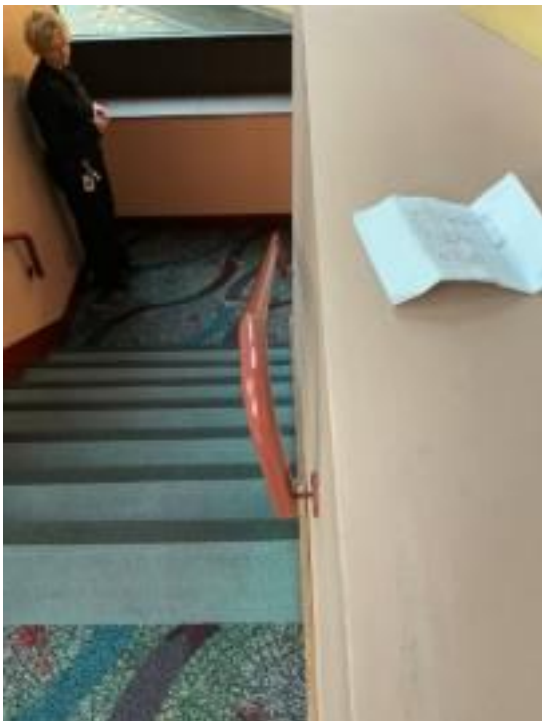
## Life Safety and Code Violation: Stair Handrails and Balustrades

At the Park Avenue entrance, the metal handrails along the interior lobby stair are loose and no longer securely fastened. Portions show movement when tested, indicating fastener failure and general deterioration.

Re-secure the handrails by tightening or replacing anchorage hardware, repair or replace compromised sections, and ensure handrails meet current safety and code requirements.

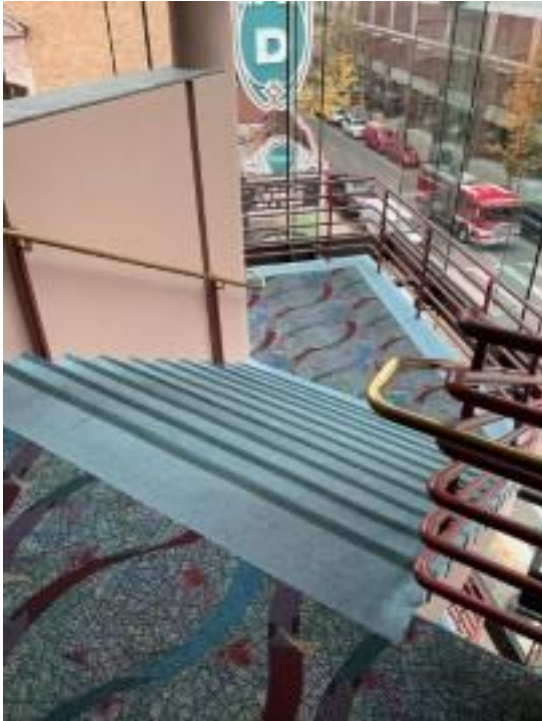
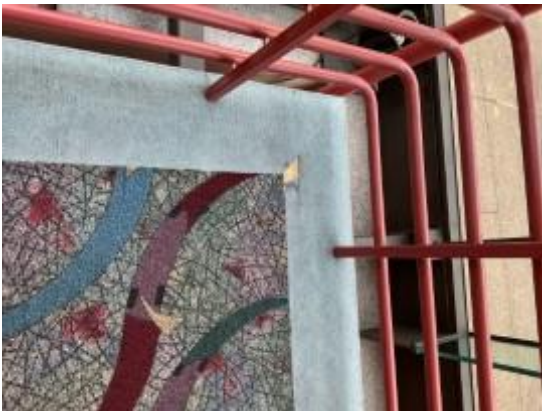
## End of Useful Life: Stair, Tread and Landing Finishes

C2221 Stair, Tread and Landing Finishes

Replace carpet on all public stair treads and associated landings with new commercial-grade stair carpet, including proper edge binding/nosing and underlayment as required; patch and repair substrate as needed before installation.

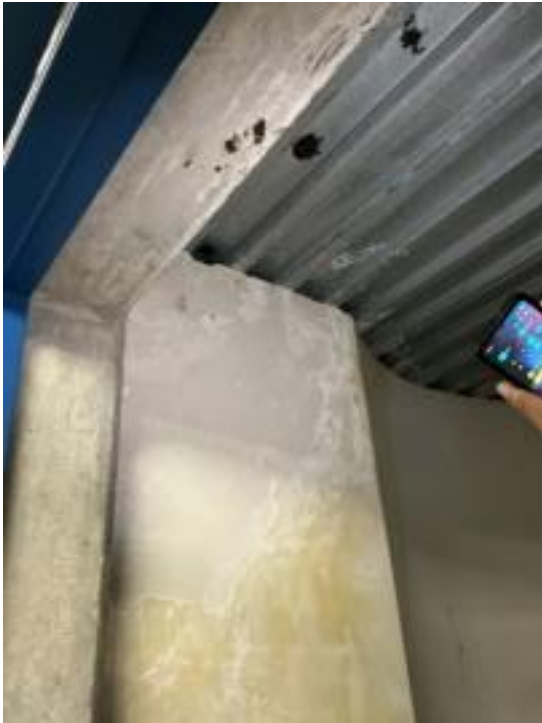
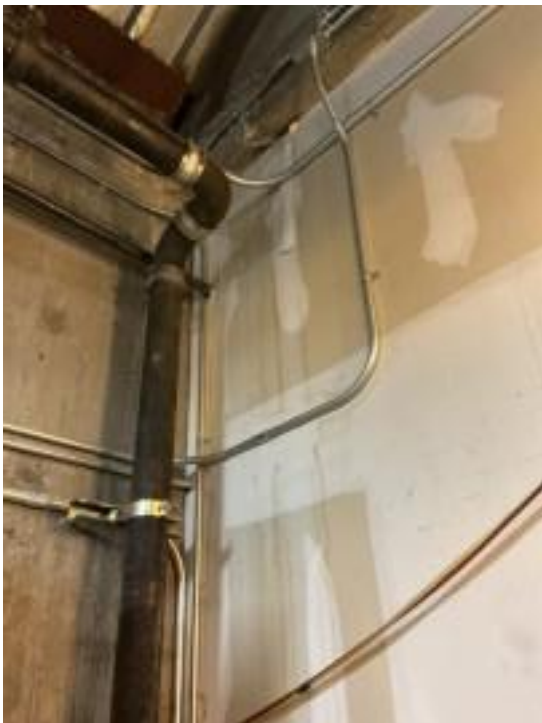
## End of Useful Life: Wall Finishes to Inside Exterior Walls

Significant water staining, efflorescence, and cracking observed on gypsum wall surfaces and concrete interface at the top of the 5th-floor spiral stair (bulkhead to roof). Moisture intrusion appears to originate at the underside of the metal roof deck and exterior wall junction. Wallboard finish is deteriorated, with visible discoloration, delamination, and cracking.

Investigate and repair the source of water intrusion at the bulkhead/roof junction. Remove damaged gypsum wall material, perform mold-resistant replacement where required, patch and skim-coat affected wall areas, and repaint to match existing. If water damage extends into the metal deck, coordinate to follow in sequence any roofing/envelope Corrective Actions.

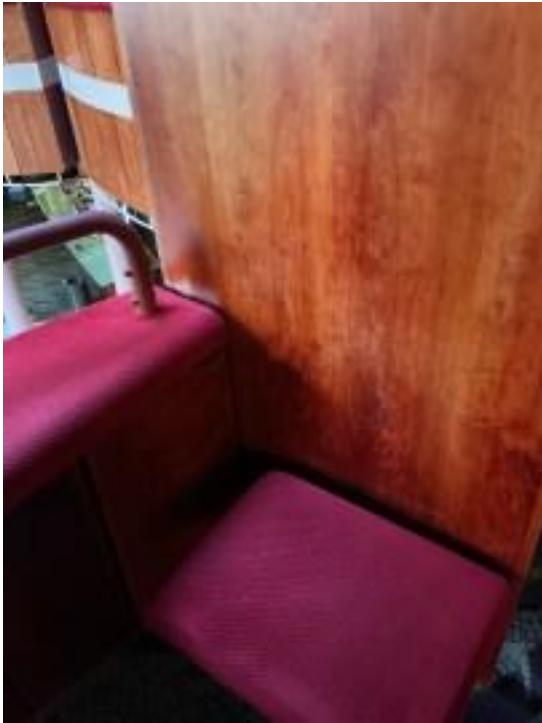
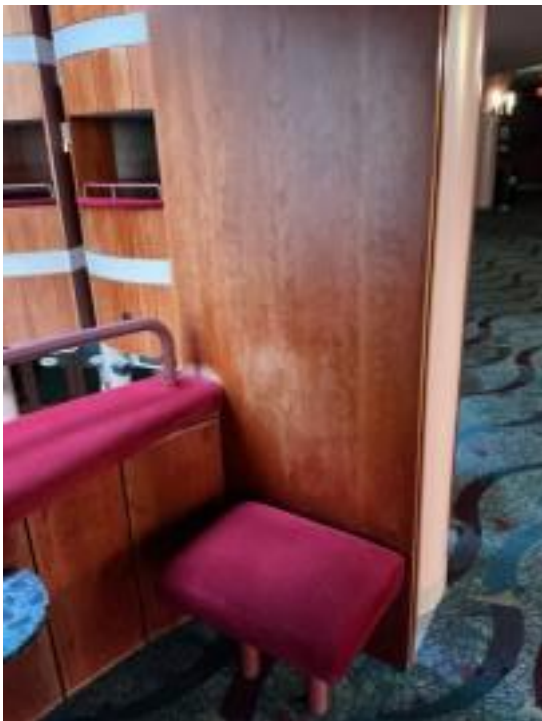
## Major Maintenance: Wall Finishes to Interior Walls

C3112 Wall Finishes to Interior Walls

Replace affected millwork panels to restore uniform appearance and protect wood surfaces.

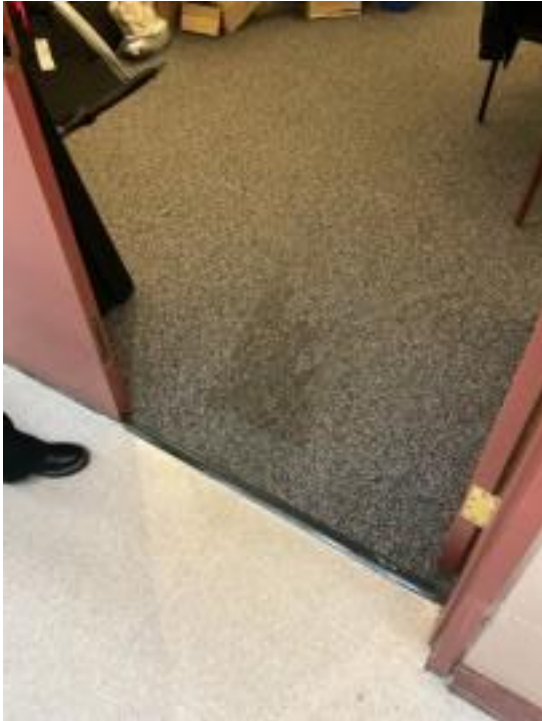
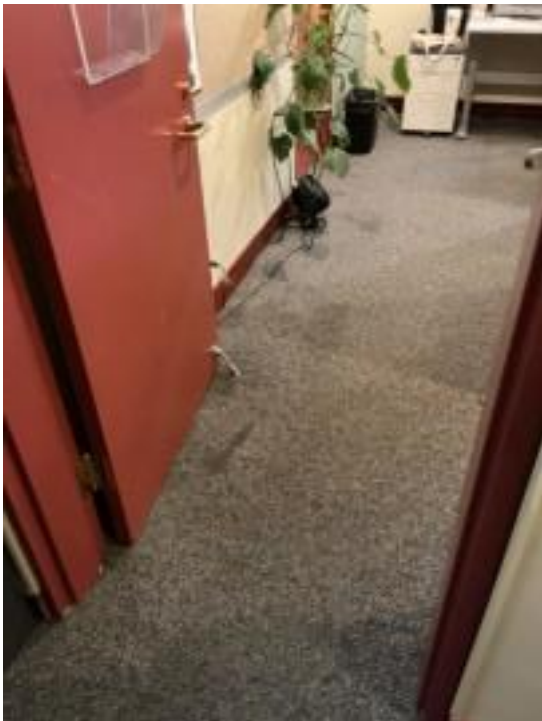
## End of Useful Life: Carpeting

C3225 Carpeting

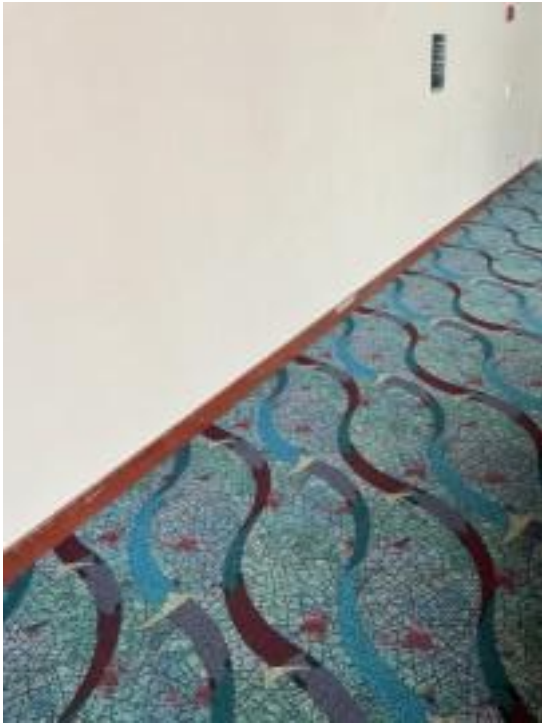
## End of Useful Life: Bases, Curbs and Trim

C3226 Bases, Curbs and Trim

Refinish or replace damaged wood baseboards to restore appearance and provide a durable protective finish.

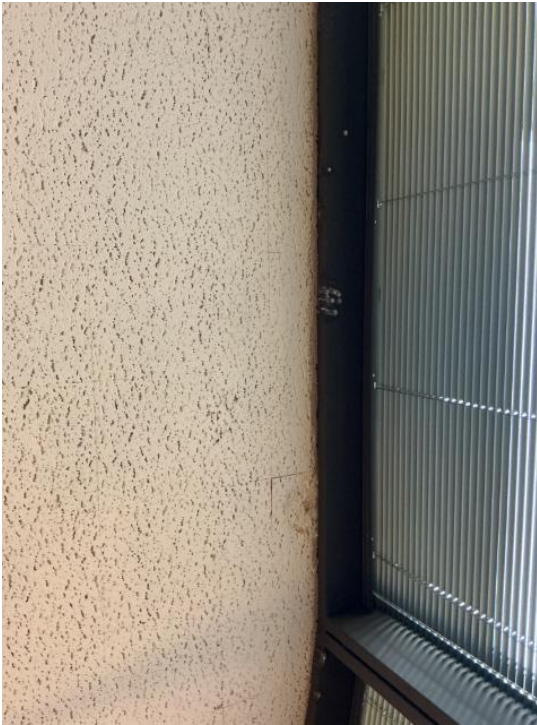
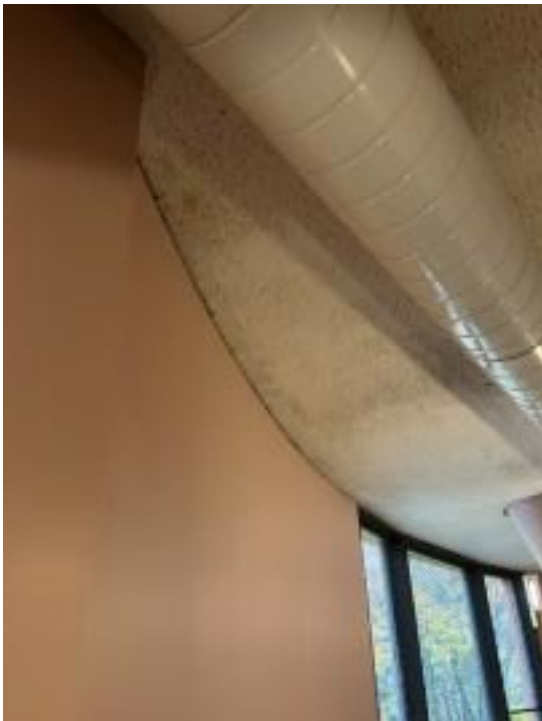
## Additional Evaluation Needed: Ceiling Finishes

C3331 Ceiling Finishes

Investigate source of moisture infiltration and repair as needed (coordination required with Envelope/Structural; evaluation cost not included in cost). After resolving moisture source, remove and replace damaged ceiling finish areas and restore adjacent surfaces to match existing texture and paint. Price reflects cost of evaluation only.

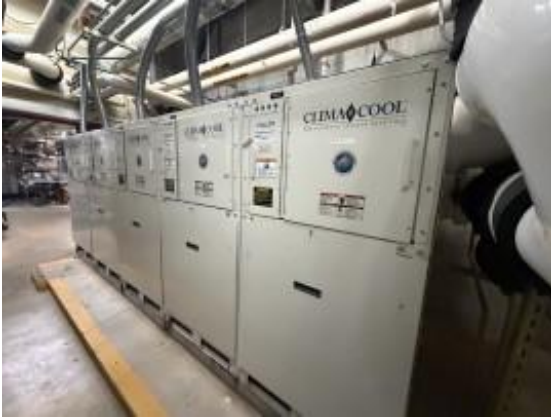
## End of Useful Life: Chilled Water Systems

D3331 Chilled Water Systems

Replace chiller.

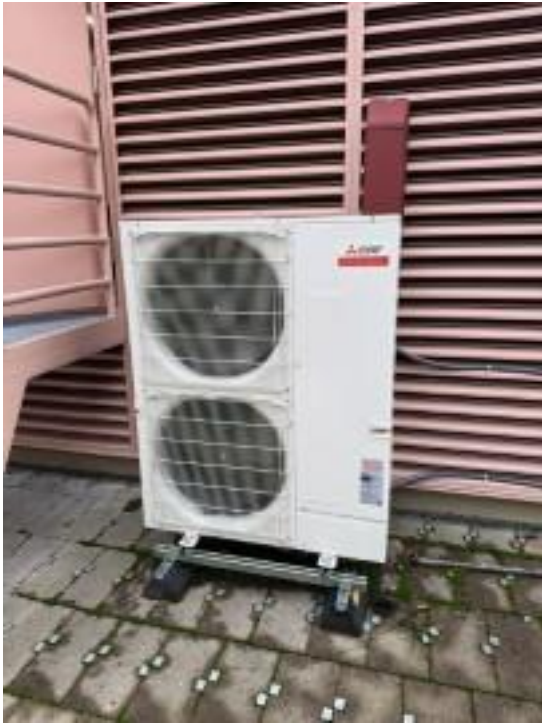
## Major Maintenance: Cooling Generating Systems

D3662 Cooling Generating Systems

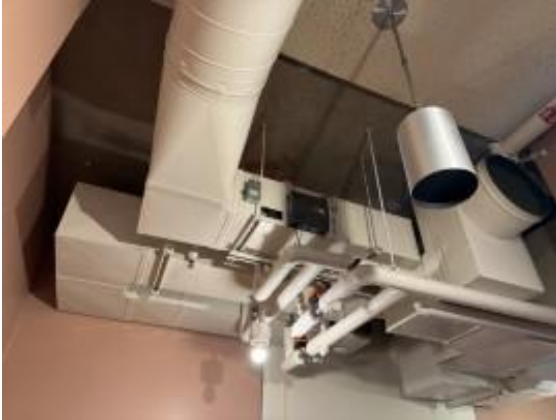
## Additional Evaluation Needed: Air systems Testing & Balancing

D3772 Air systems Testing & Balancing

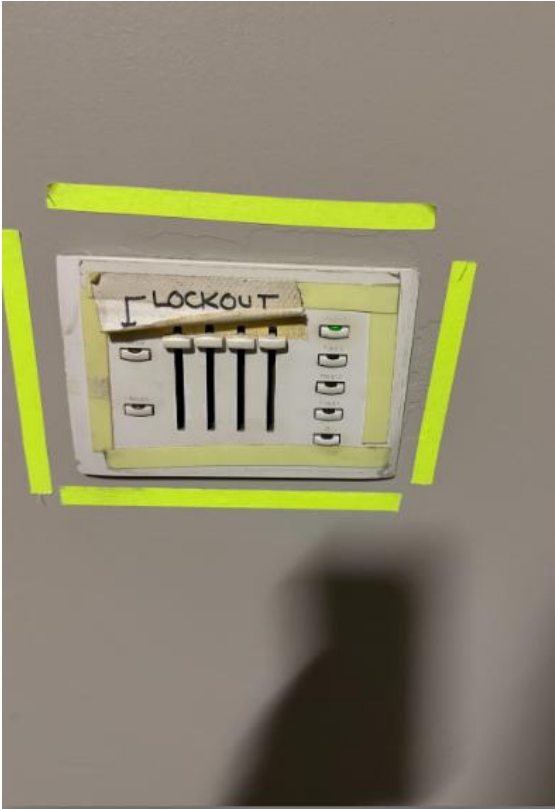
## End of Useful Life: Lighting Controls

D5223 Lighting Controls

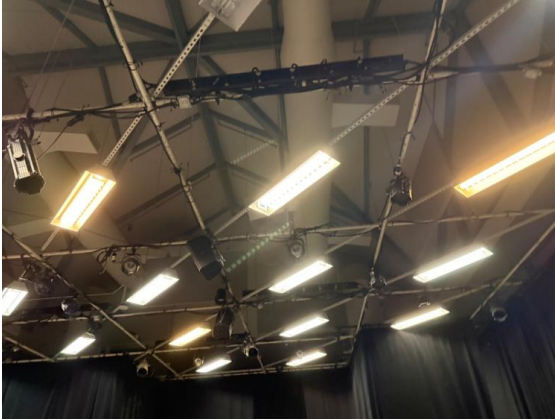
## Life Safety and Code Violation: Emergency Light & Power Systems

D5992 Emergency Light & Power Systems

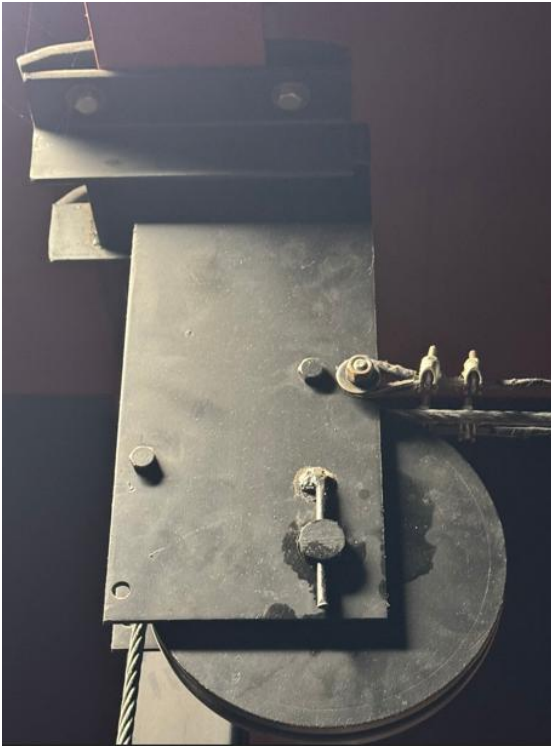
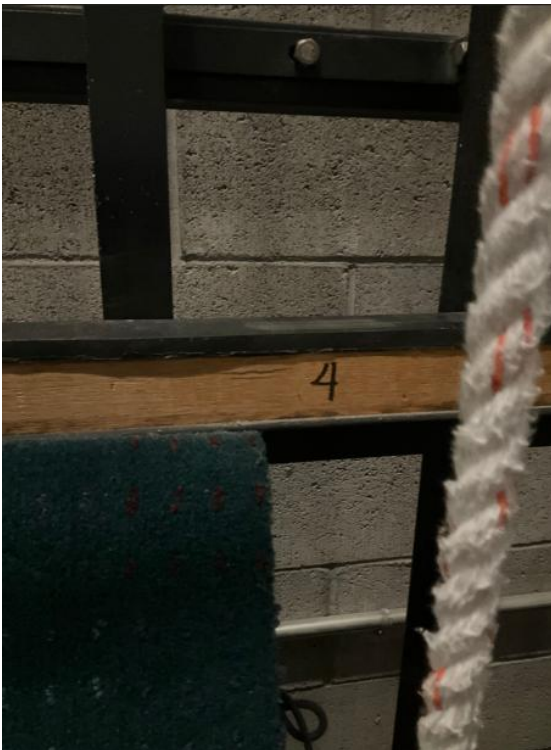
## End of Useful Life: Theater & Stage Equipment

E1223 Theater & Stage Equipment

Manual and motorized stage rigging in the Winningstad has exceeded the manufacturer's recommended useful life and should be replaced. Manual stage rigging equipment in the Newmark has exceeded the manufacturer's recommended useful life and should be replaced. Pipe grid in the Brunish appears to be well maintained, though no lateral seismic bracing is in place, and should be added as part of any improvements to the space.

Replace stage rigging components that have exceeded manufacturer recommended service life; inspect supporting structure; perform load testing/certification by qualified rigging contractor.

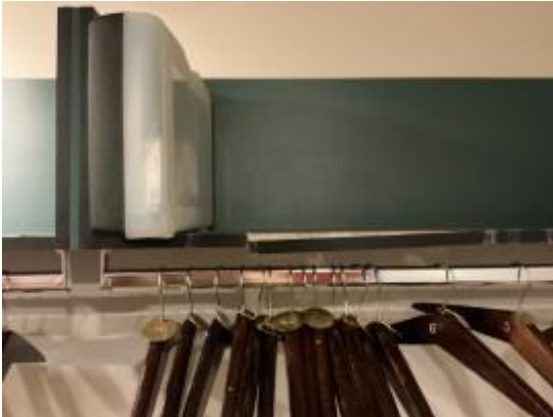
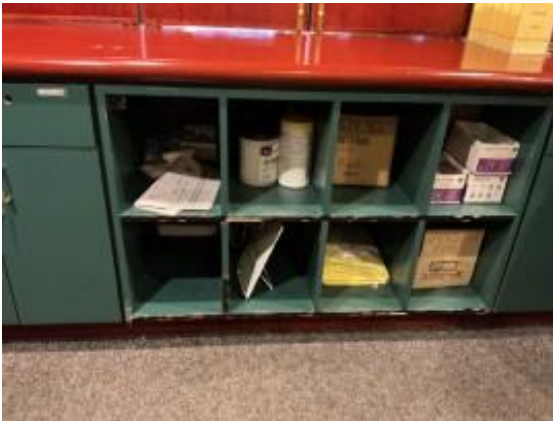
## End of Useful Life: Fixed Casework

E2112 Fixed Casework

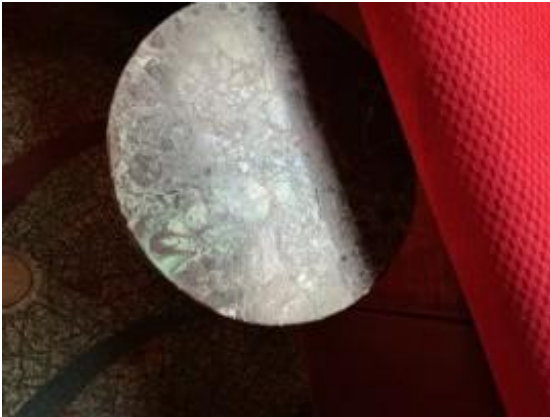
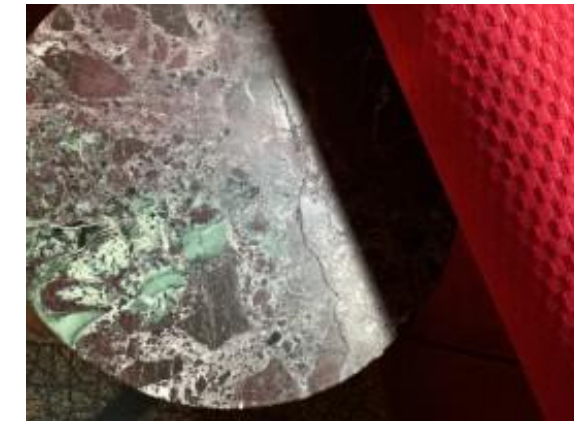
## End of Useful Life: Fixed Casework

E2112 Fixed Casework

Replace deteriorated stone cocktail tables at alcoves surrounding the rotunda, including correction of anchorage and replacement of cracked surfaces.
