# Metro Portland'5 Centers for the Arts

Facility Condition Assessment for  
Antoinette Hatfield Hall

April 10, 2026 | Prepared by: Sazän Group

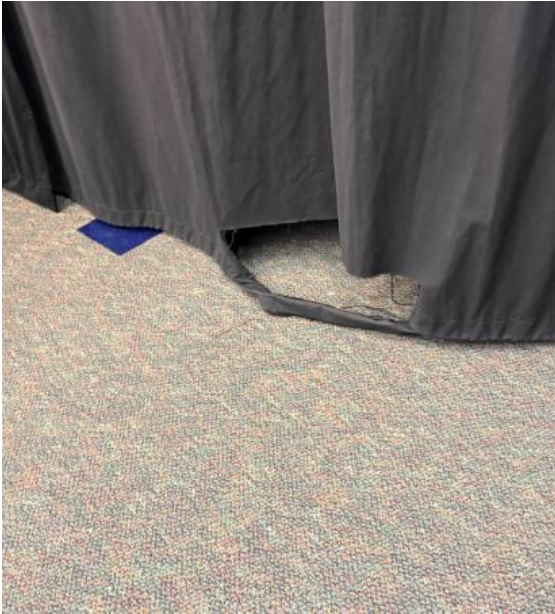
## End of Useful Life: Movable Rugs and Mats

E2223 Movable Rugs and Mats

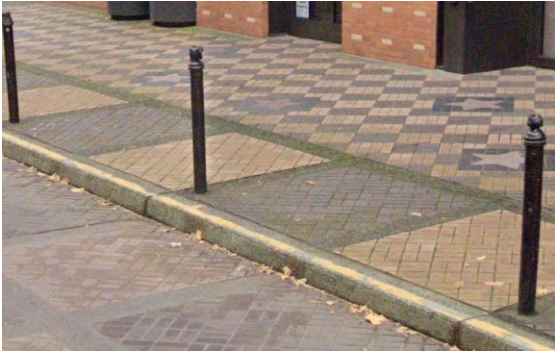
## Life Safety and Code Violation: Painted Lines

G2115 Painted Lines

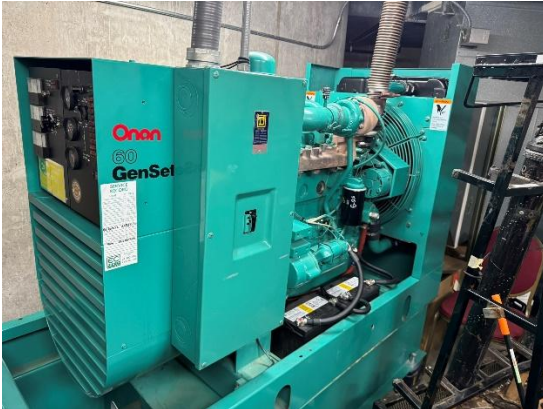
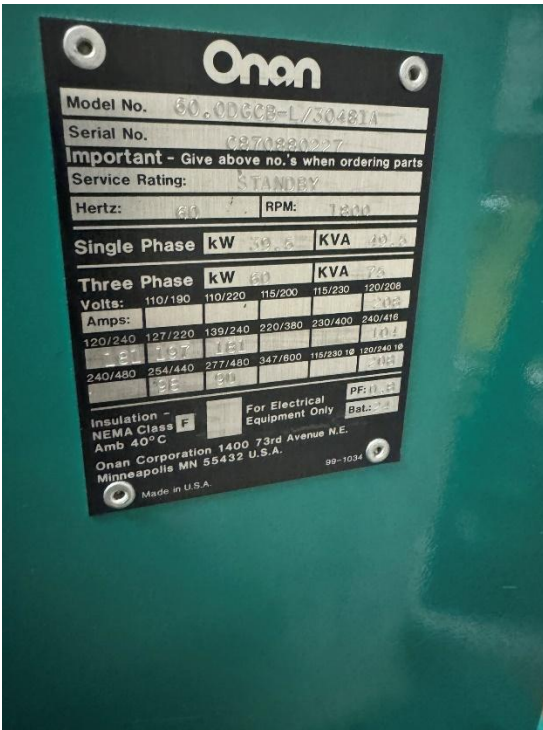
## End of Useful Life: Site Emergency Power Generation

G4992 Site Emergency Power Generation
