## Metro Portland's 5 Centers for the Arts

Facility Condition Assessment for

### Arlene Schnitzer Concert Hall

April 10, 2026 | Prepared by: Sazän Group

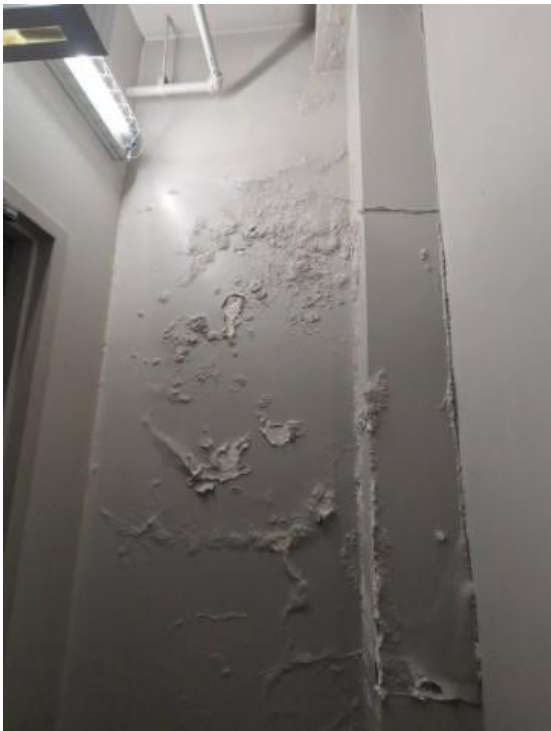
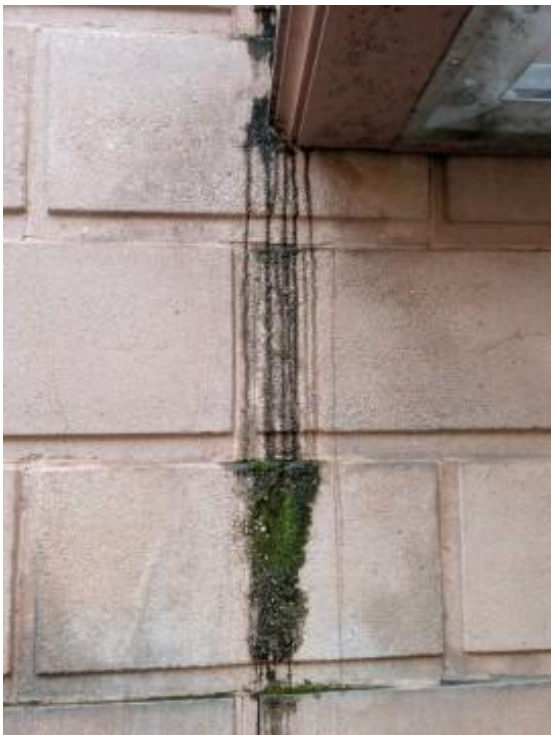
B1113 Balcony Floors Construction

Balcony framing interface with exterior wall is a common failure point. Water intrusion is occurring at some locations and is damaging interior finishes. Masonry stains of the adjacent masonry units indicates moisture saturation at the balcony to wall connections.

We recommend a repair is designed and implemented to waterproof the balcony to wall connections, flashing transitions and the renewal the adjacent masonry elements.

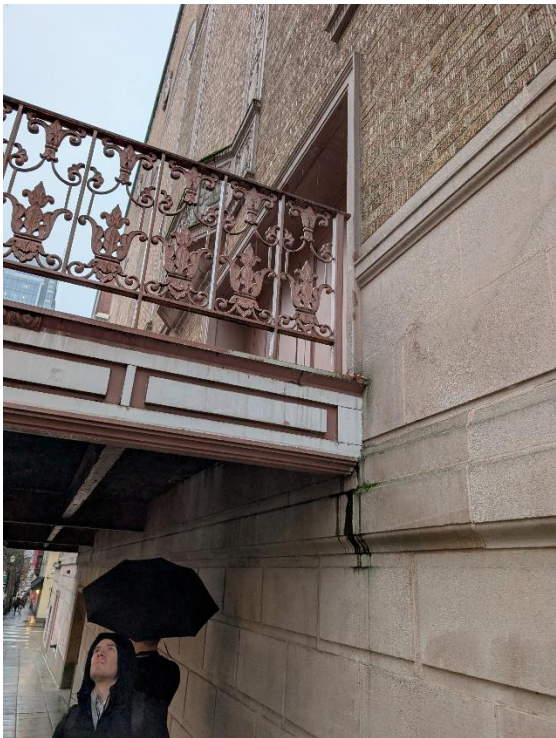
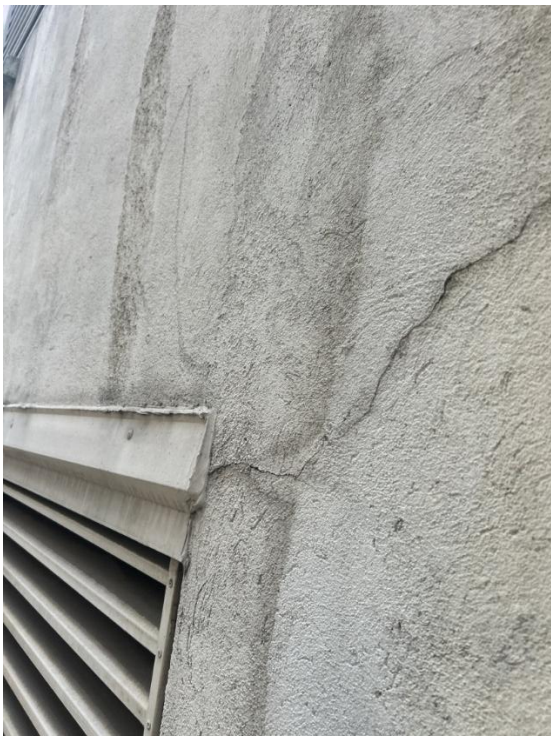
B2113 Exterior Louvers, Screens and Fencing

Some damaged louver units. Does not appear to affect adjacent exterior assembly.

Replace damaged louver units; repair surrounding frames/flashing and reseal to maintain weather-tightness.

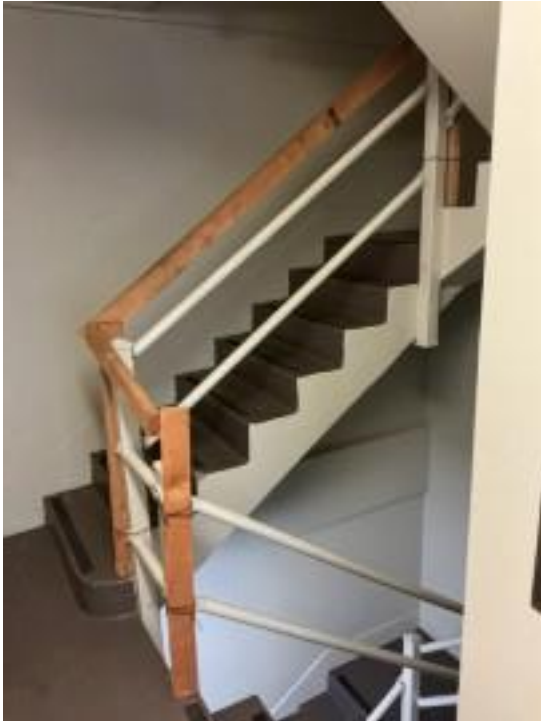
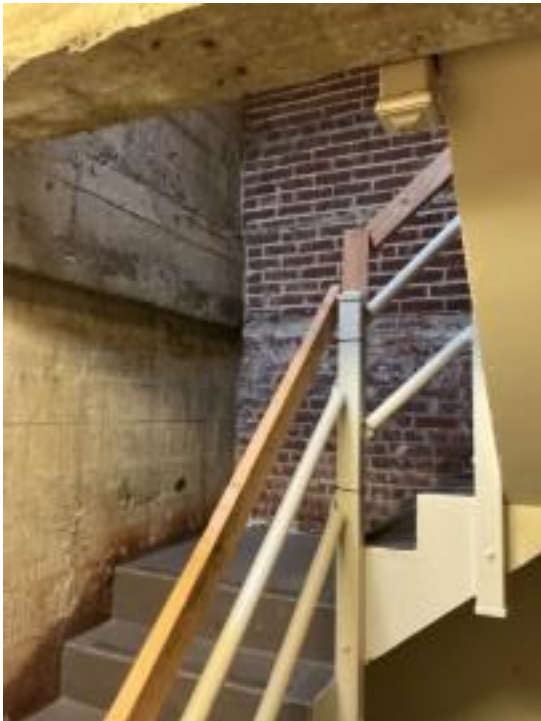
C2114 Stair Handrails and Balustrades

Temporary wood handrail extensions installed for construction safety remain in place between the 5th Floor and Bulkhead at the Dressing Room Tower. Installation appears non-permanent and inconsistent with original handrail system.

Remove temporary wood handrail extensions and restore permanent handrail configuration to match original design intent and finish.

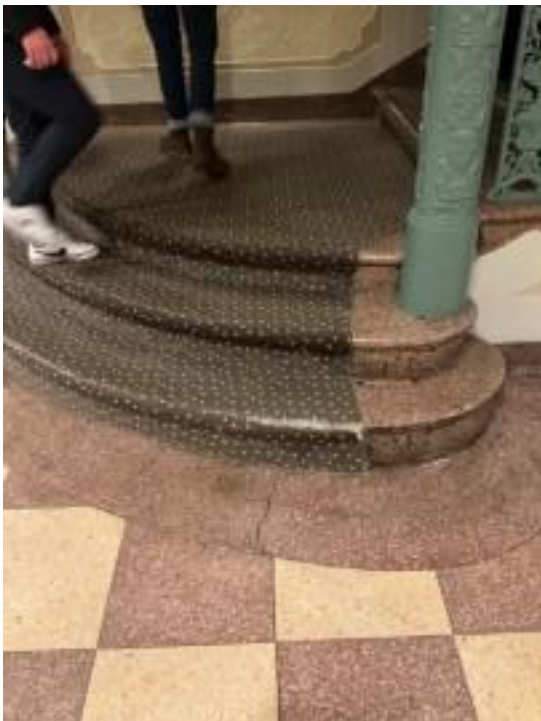
Broadloom stair carpet is worn and fraying at multiple treads, nearing the end of its useful life and creating a potential tripping hazard.

Replace existing stair carpet; remove worn material, repair substrate as needed, and install new commercial-grade stair finish suitable for public, high-traffic areas.

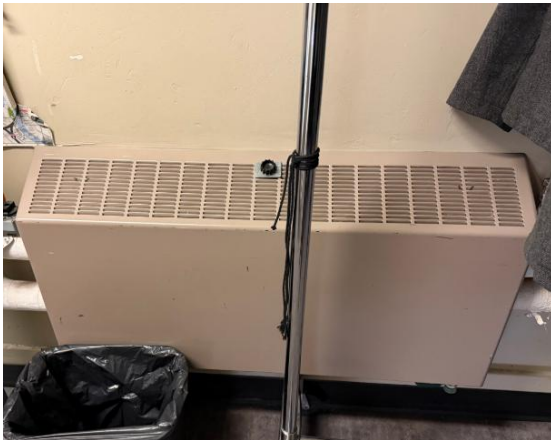
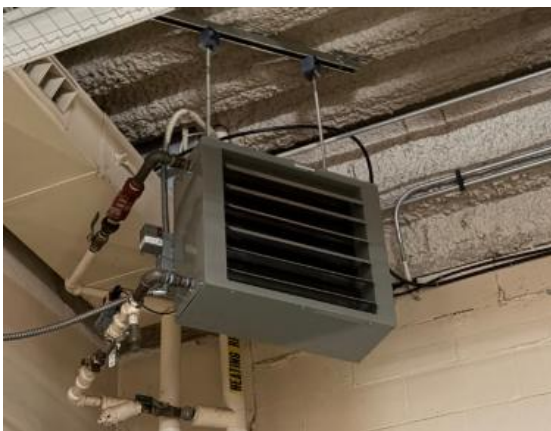
There are three hydronic unit heaters (UH-1, 2, 3) that are at end of useful life.

Replace with new heating equipment.

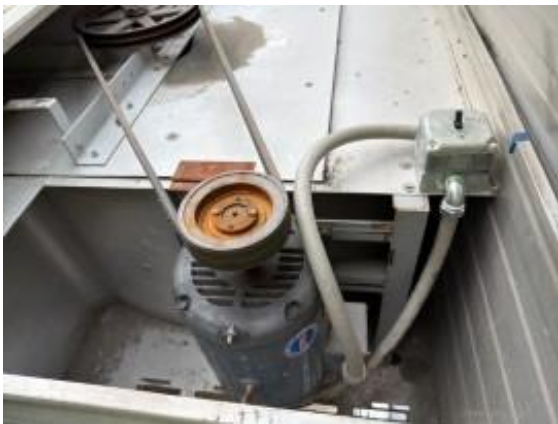
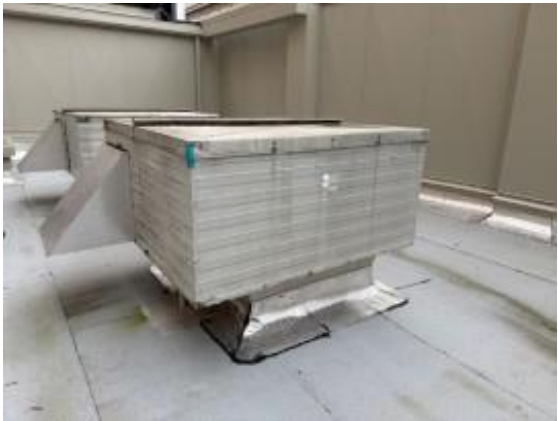
**Component**  
D3664 Exhaust & Ventilating Systems

*Picture depicts a representative sample. All fans need to be replaced.*

**Recommended Action**  
Replace all fans with new equipment.
