# Metro Portland's Centers for the Arts

## Facility Condition Assessment for Keller Auditorium

April 10, 2026 | Prepared by: Sazän Group

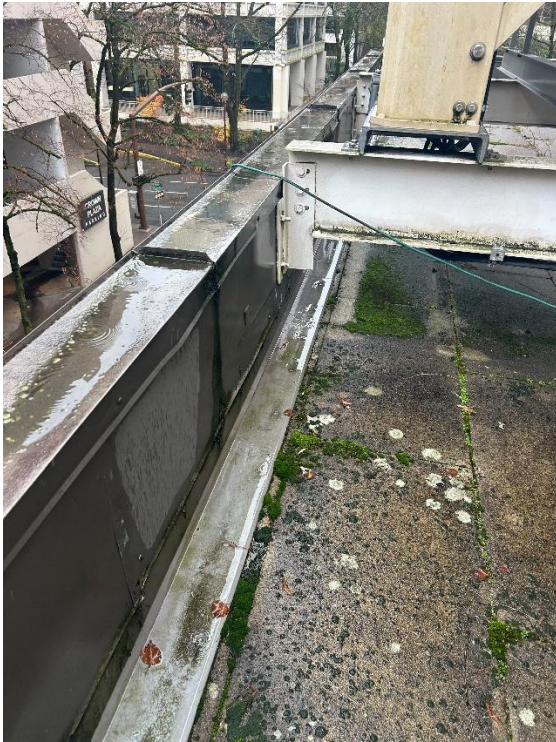
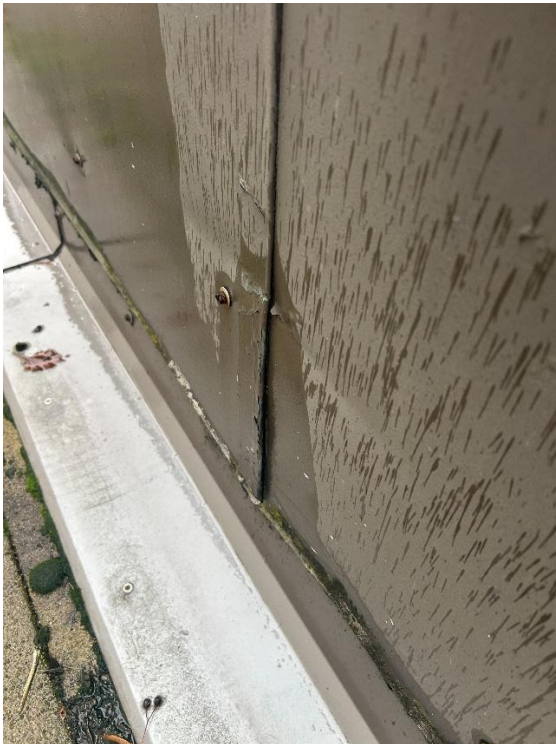
## Major Maintenance: B2112 Parapets

Parapets were in varied condition. Evidence of joint failure and damage to metal panel cladding was observed at multiple locations.

Remove failed sealants and repair parapet joints; repair/replace damaged cladding or coping; restore continuous waterproofing and drainage.

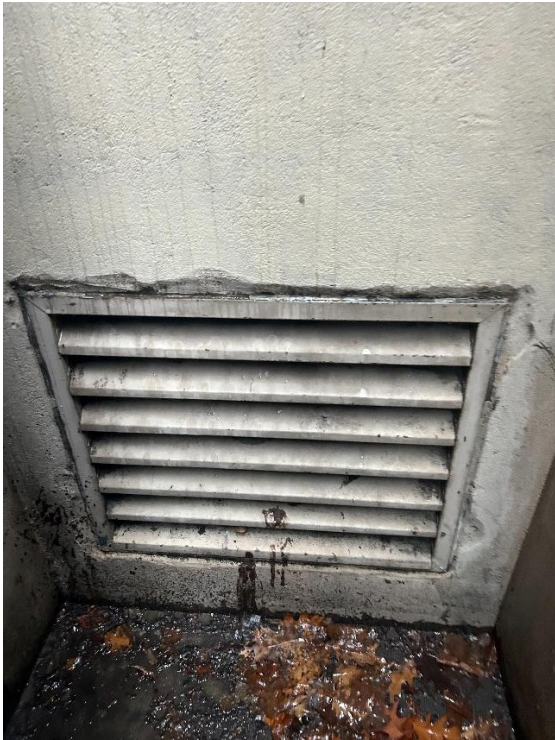
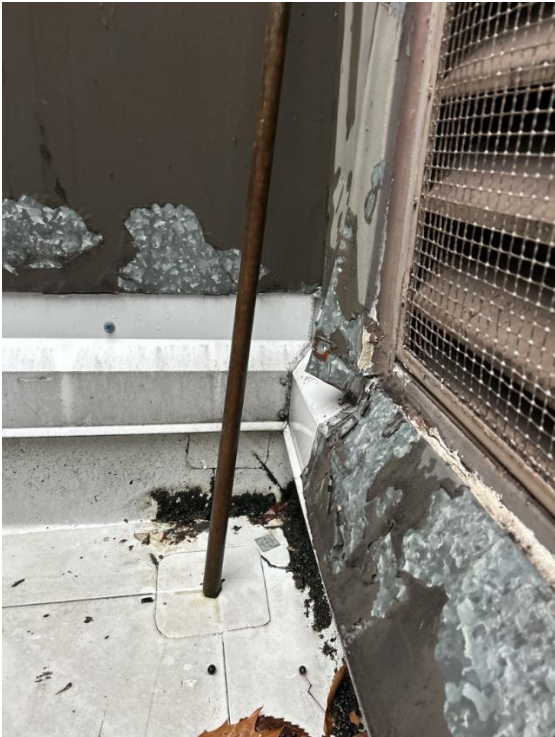
## Major Maintenance: B2113 Exterior Louvers, Screens and Fencing

Sealant joints at louvers have reached end of useful life, creating a potential water ingress path. Louvers themselves are in fair condition with some finish deterioration.

Replace all damaged louver units around the building; repair surrounding frames/flashings and reseal to maintain weather-tightness.

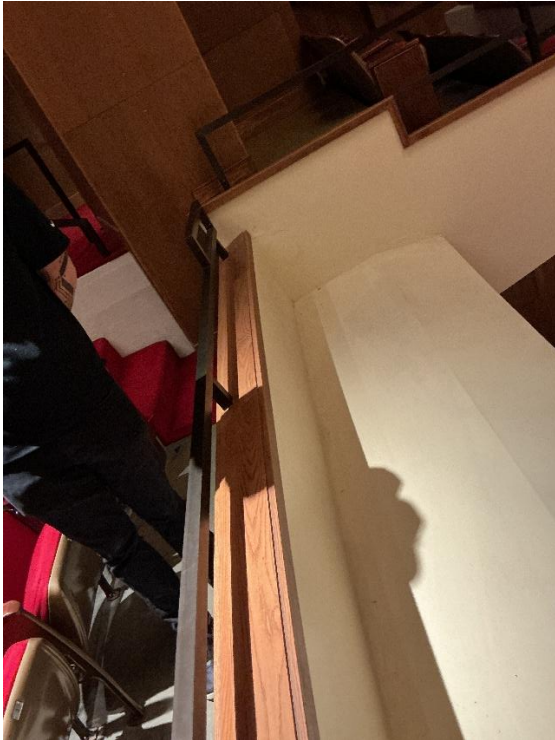
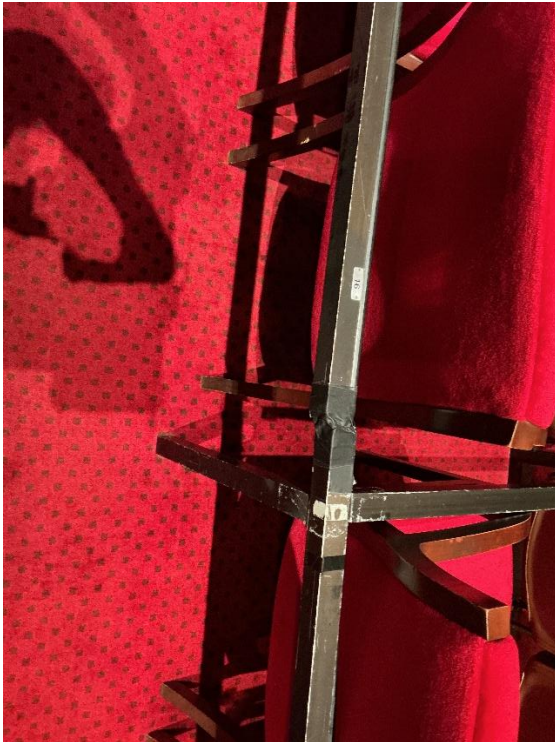
## End of Useful Life: B2115 Balcony Walls & Handrails

Balcony seating section divider rail assemblies exhibit significant wear, damage, and looseness. Several rail components are broken or inadequately secured, indicating the assemblies are nearing the end of their useful life and may not reliably perform as intended.

Repair and re-secure loose seating section divider rail components and replace damaged or broken sections. Where deterioration is widespread, replace divider rail assemblies to restore structural integrity and intended performance..

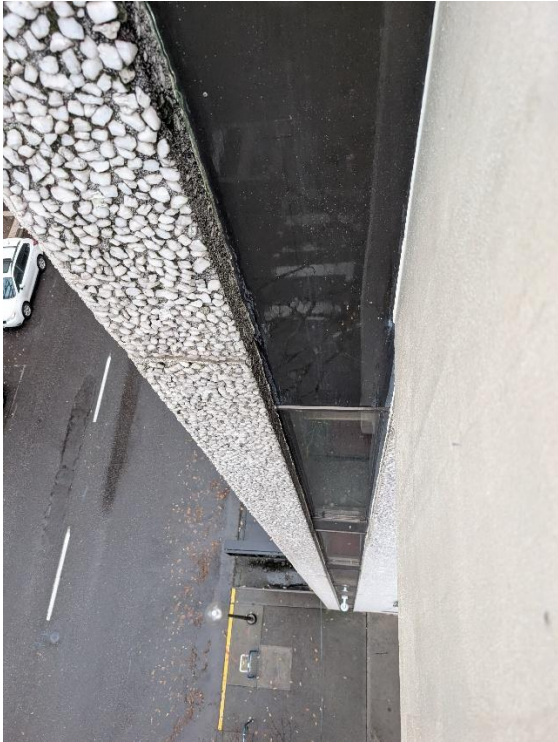
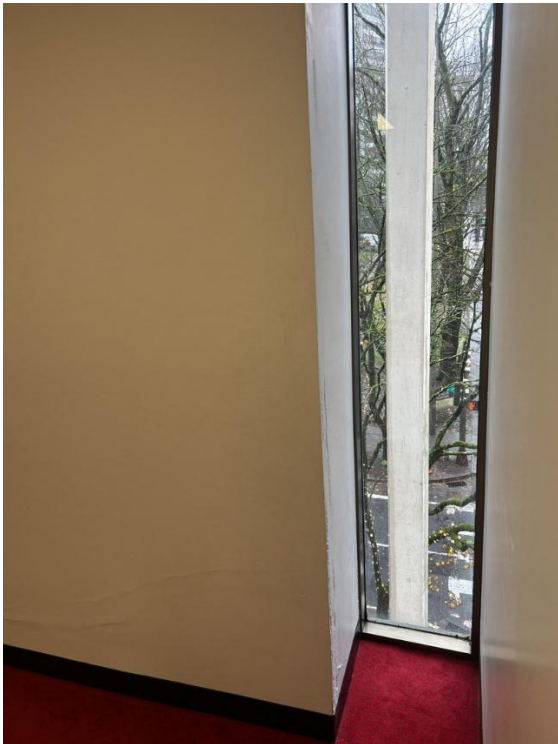
## End of Useful Life: B2221 Exterior Windows

Exterior windows are showing signs of age. Sealant joints are approaching end of useful life with some failures observed.

Identify leak locations and repair window/frame interfaces; replace failed gaskets/sealants; repair/replace damaged hardware and refinish coatings.

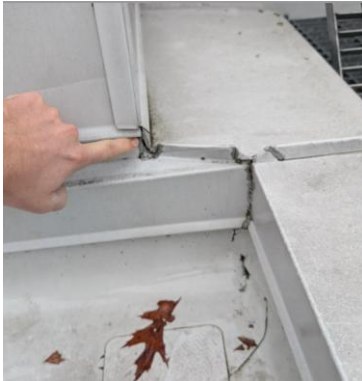
*Gap in wall to roof flashing*

Remove and replace failed flashing and sealant at deficient joints and transitions. Repair adjacent finishes as required and verify proper drainage at affected locations.

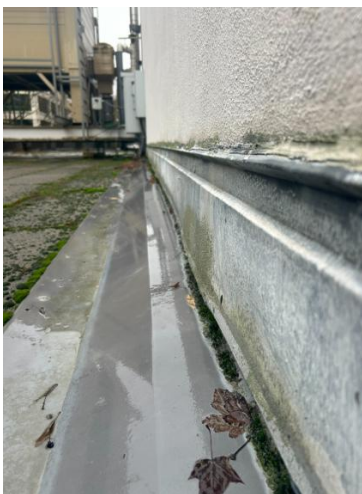
*Wear and organic growth observed at wall flashing*

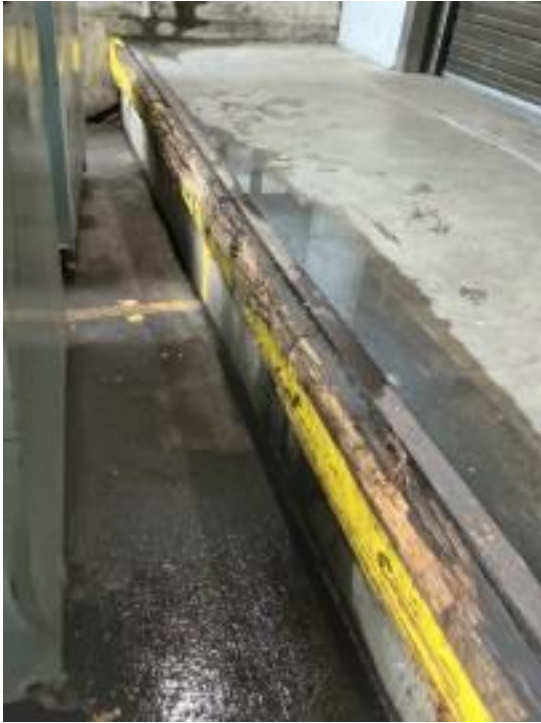
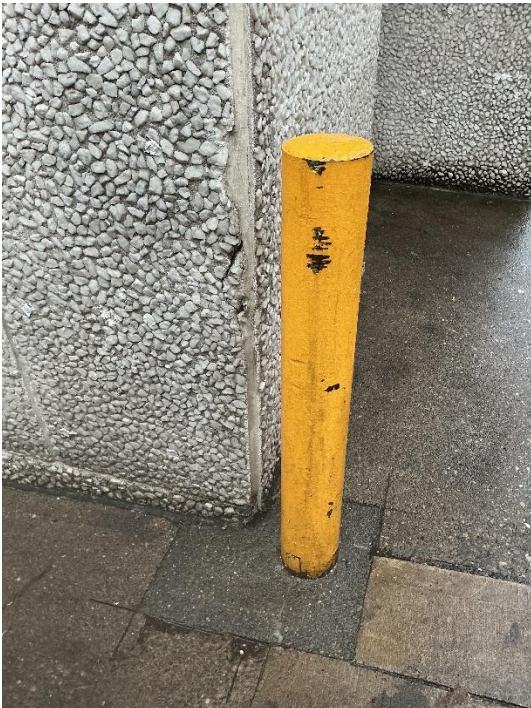
## End of Useful Life: E1333 Loading Dock Equipment

Wood bumper rail at the loading dock exhibits significant deterioration, including splitting, crushing, and material loss consistent with repeated impact from delivery and service vehicles, reducing protection at the dock edge. The adjacent building corner at the loading dock entrance shows visible impact damage and is not fully protected by existing bollards.

Remove and replace deteriorated wood bumper rail with a heavy-duty bumper system designed to withstand repeated truck impacts. Install an additional fixed steel bollard at the building corner adjacent to the loading dock entrance to provide direct impact protection where damage has occurred.
