## Metro Portland's 5 Centers for the Arts

Facility Condition Assessment for

### Arlene Schnitzer Concert Hall

April 10, 2026 | Prepared by: Sazän Group

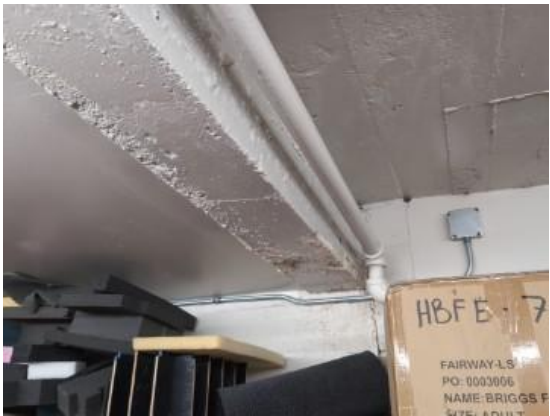
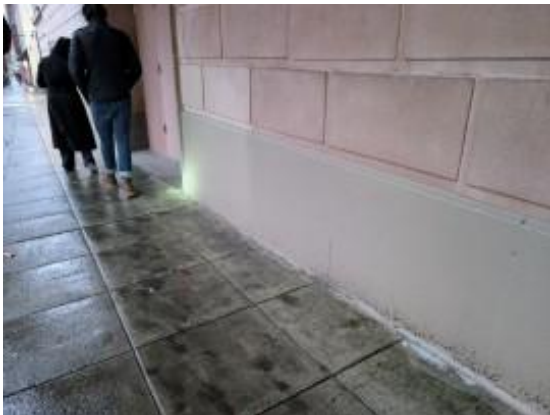
Additional Evaluation Needed: Basement Wall Construction

| A2221 Basement Wall Construction |

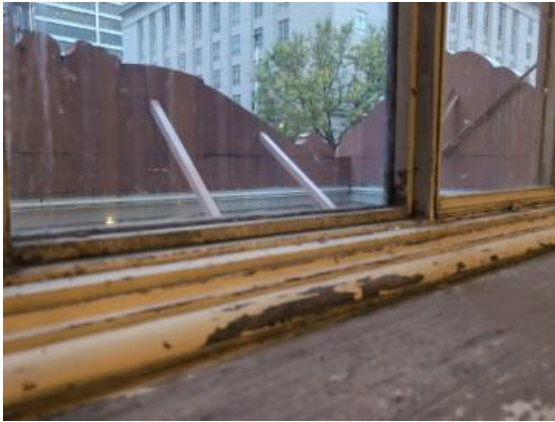
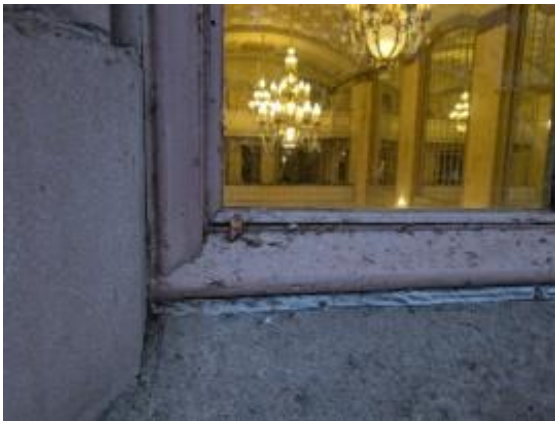
## Major Maintenance: Exterior Curtain Walls

B2222 Exterior Curtain Walls

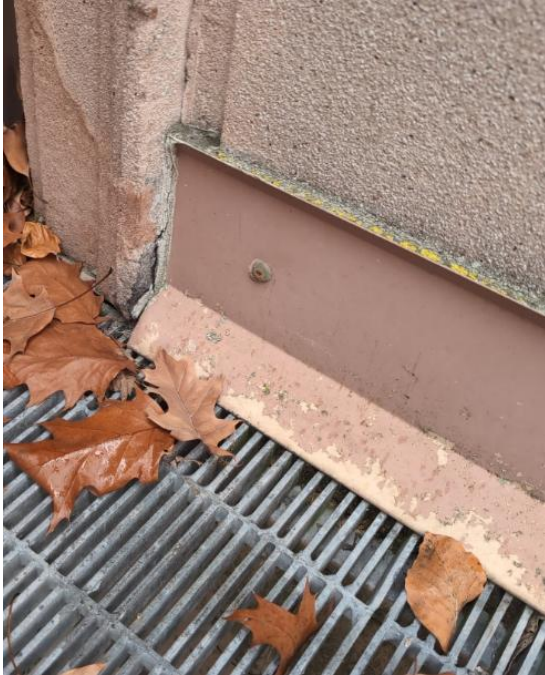
## Major Maintenance: Flashings & Trim

B3114 Flashings & Trim

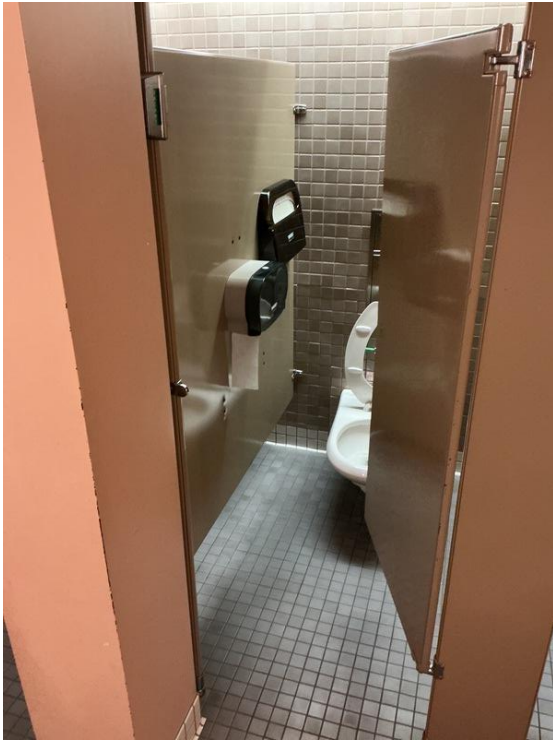
## End of Useful Life: Fabricated Toilet partitions

C1331 Fabricated Toilet Partitions

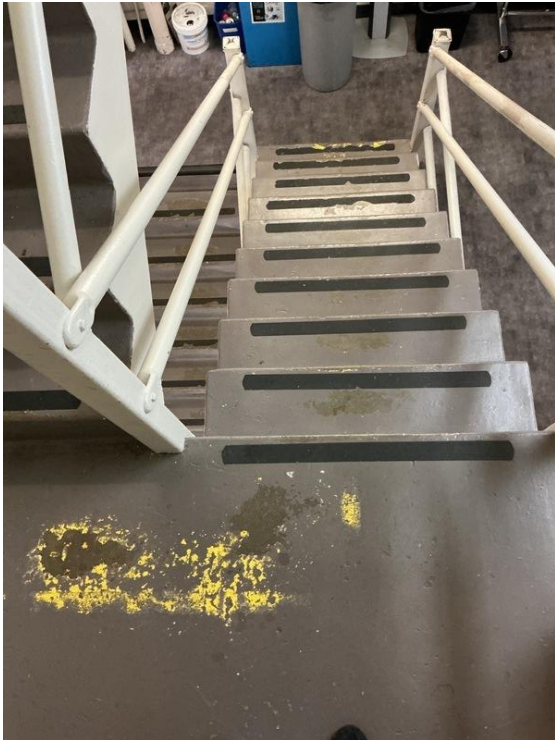
## End of Useful Life: Stair, Tread and Landing Finishes

C2221 Stair, Tread and Landing Finishes

Prep and refinish all treads and landings with a slip-resistant coating and new safety striping.

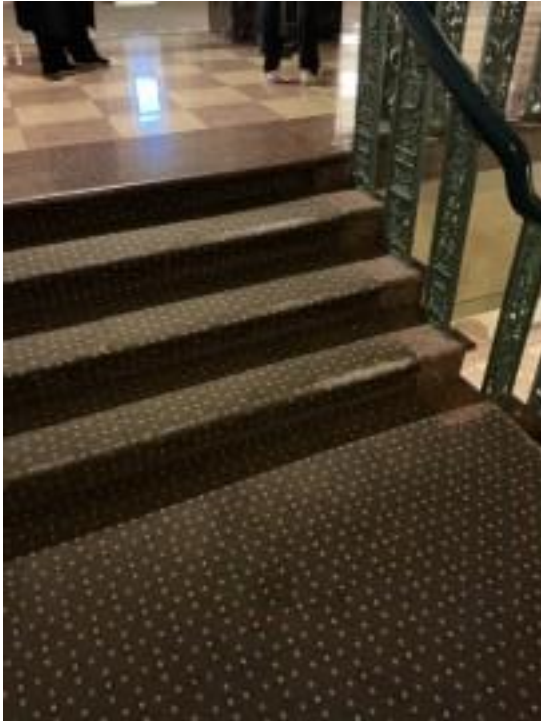
## End of Useful Life: Stair, Tread and Landing Finishes

C2221 Stair, Tread and Landing Finishes

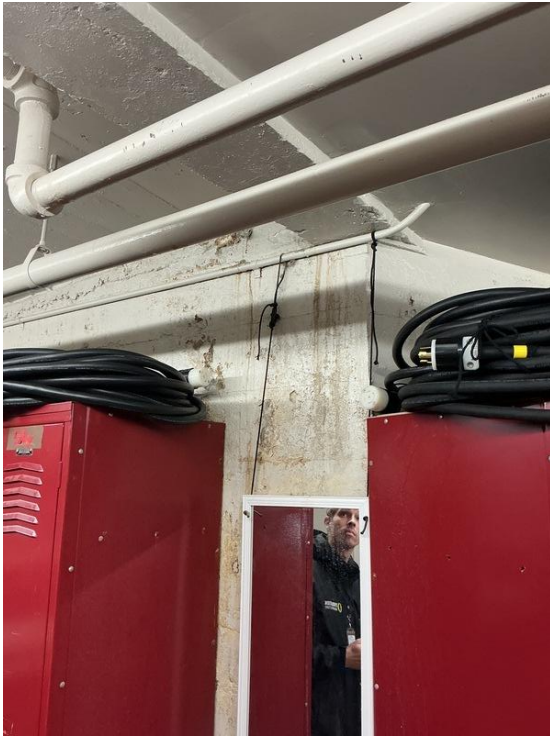
## Additional Evaluation Needed: Wall Finishes to Inside Exterior Walls

C3111 Wall Finishes to Inside Exterior Walls

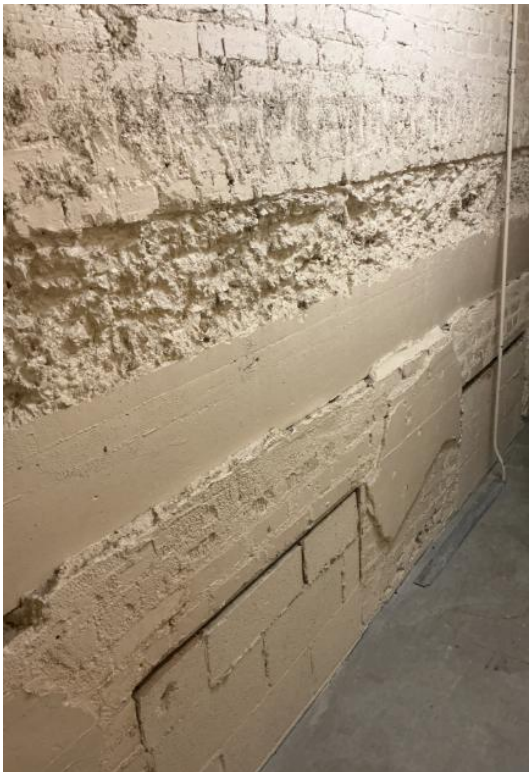
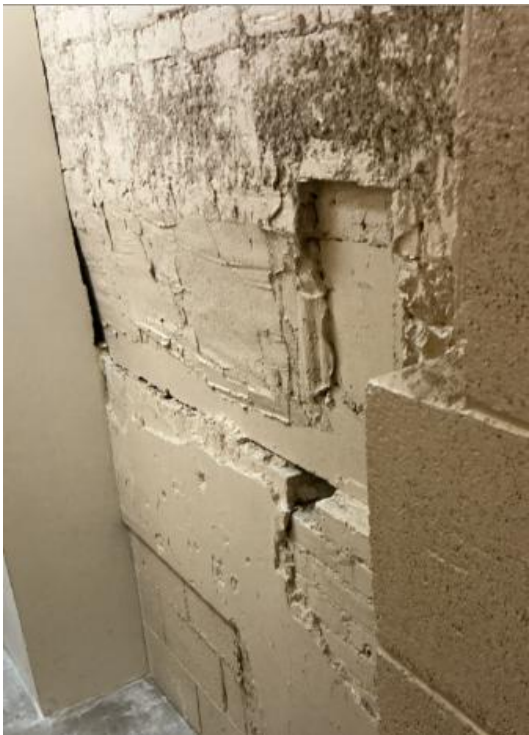
Additional Evaluation Needed: Wall Finishes to Inside Exterior Walls

C3111 Wall Finishes to Inside Exterior Walls

Remove loose or damaged wall material, repair substrate as needed, refinish affected wall sections, and repaint to match existing. Coordinate with Envelope team to confirm whether underlying moisture issues are active and address them prior to finish repairs. Pricing reflects evaluation only.

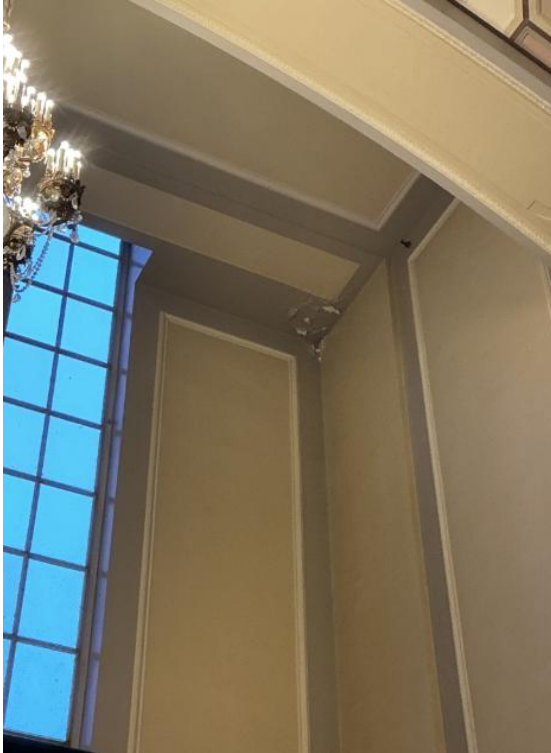
## Additional Evaluation Needed: Wall Finishes to Inside Exterior Walls

C3111 Wall Finishes to Inside Exterior Walls

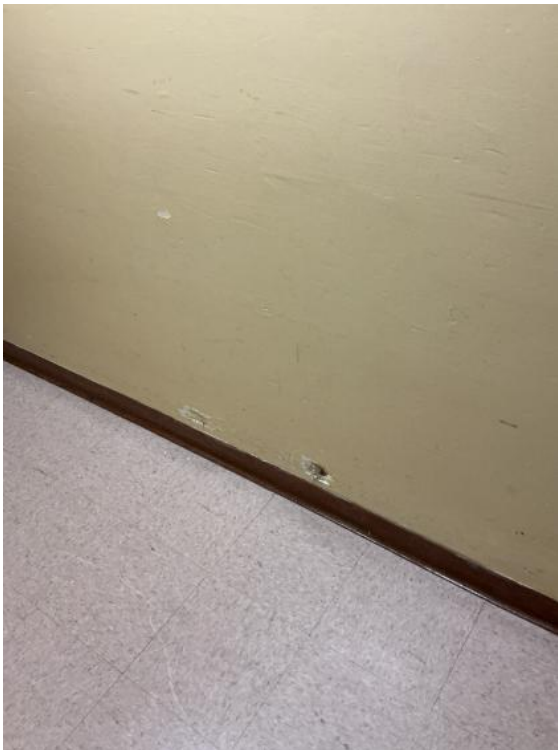
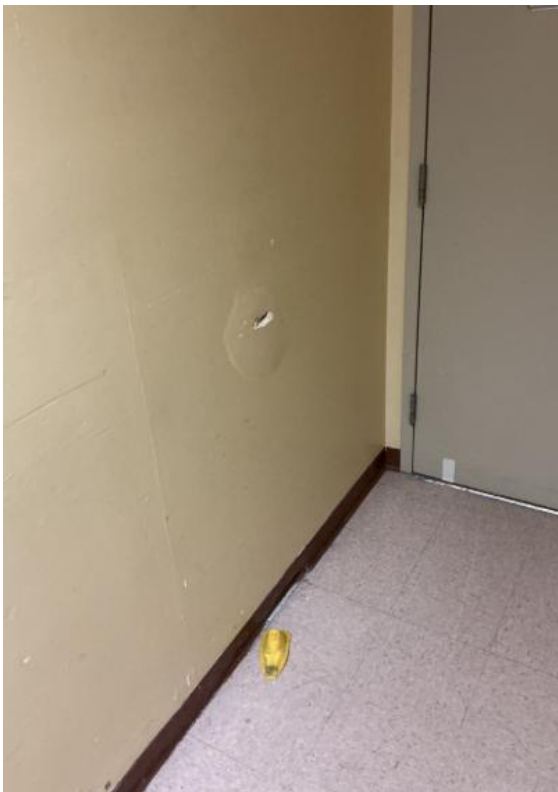
Major Maintenance: Wall Finishes to Interior Walls

C3112 Wall Finishes to Interior Walls

Patch and repair damaged wall sections, restore finish to a smooth condition, and repaint to match surrounding surfaces.

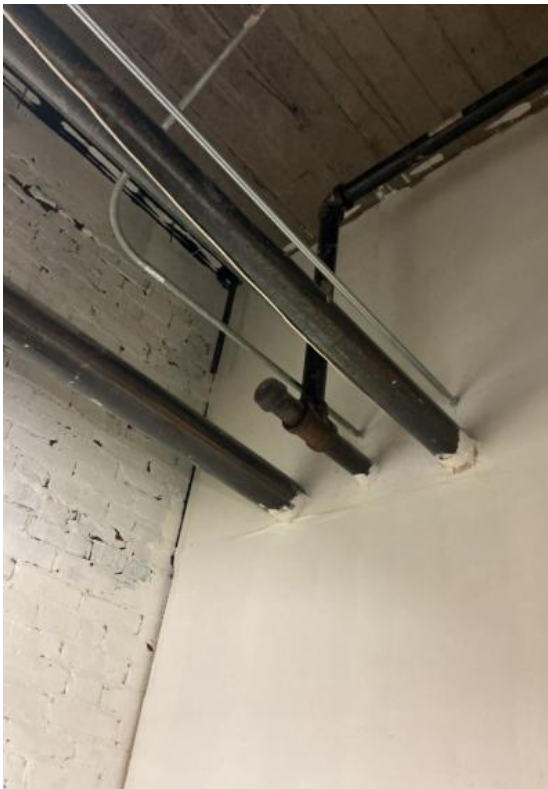
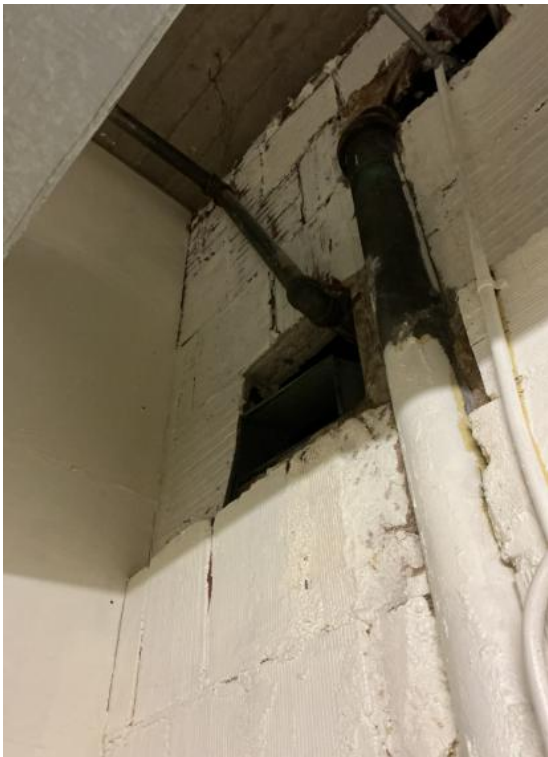
Major Maintenance: Wall Finishes to Interior Walls

C3112 Wall Finishes to Interior Walls

Repair damaged wall sections; remove loose or compromised material, patch and refinish affected areas, and repaint to match existing finishes. Coordinate with Envelope team to confirm and address the source of moisture intrusion prior to completing repairs.

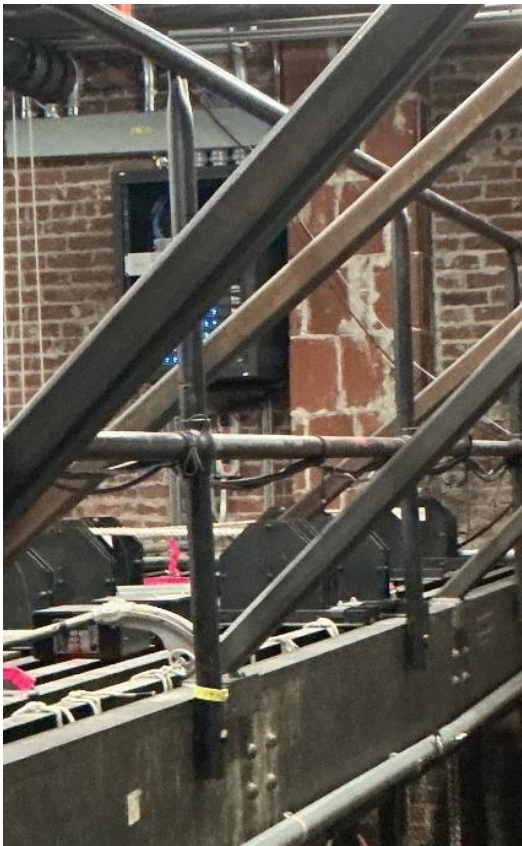
End of Useful Life: Column Finishes

C3113 Column Finishes

Remove deteriorated terra cotta column enclosure and evaluate current fire-resistance requirements. Provide a code-compliant fire-rated column protection system if required; if fire protection is no longer required, remove the enclosure and repair adjacent finishes with appropriate materials.

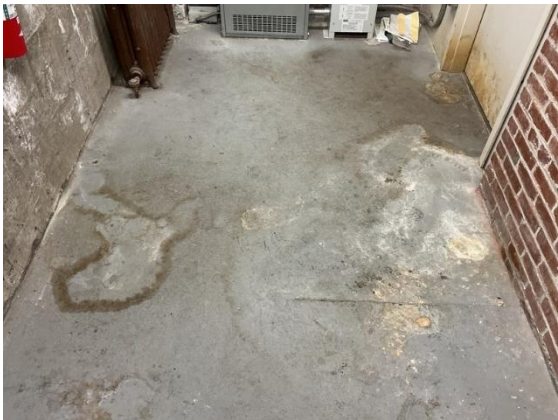
Major Maintenance: Flooring

C3224 Flooring

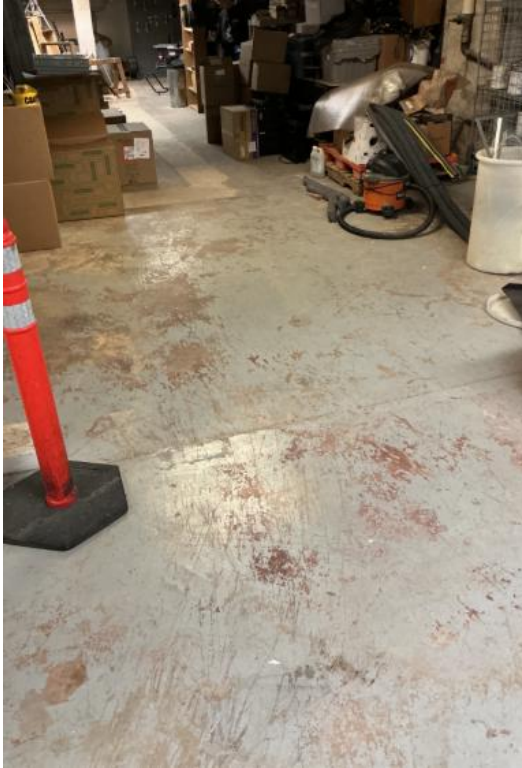
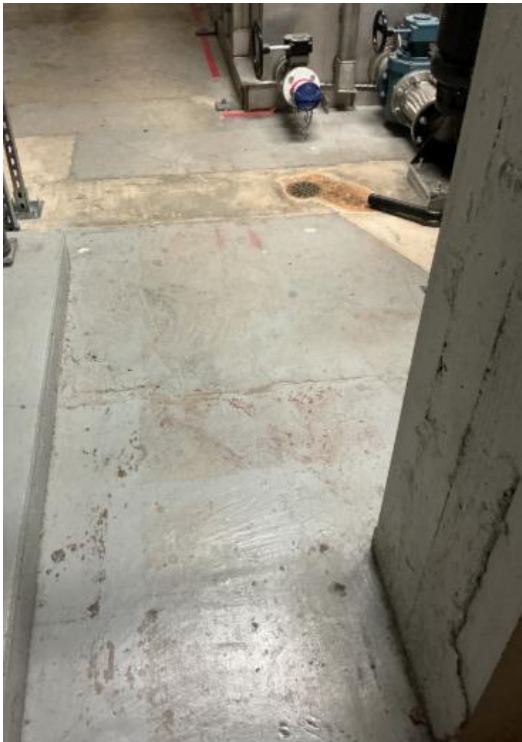
## End of Useful Life: Flooring

C3224 Flooring

Prep and refinish concrete floor with a new durable coating system (e.g., epoxy or industrial concrete paint).

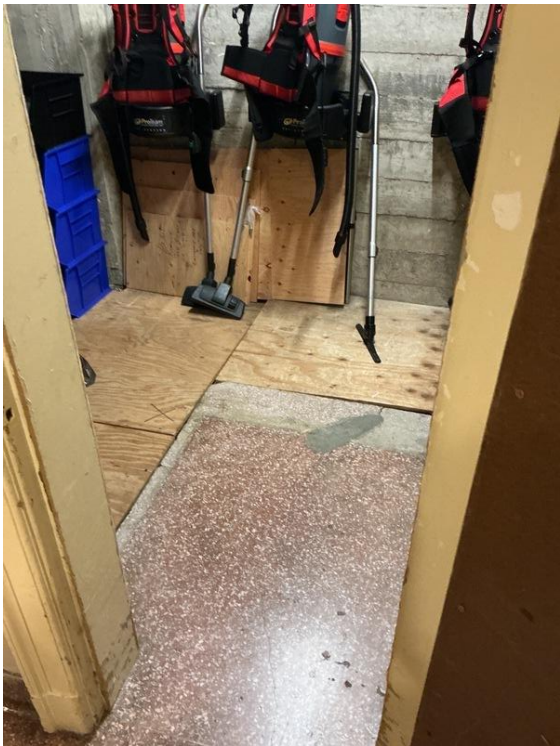
Major Maintenance: Flooring

C3224 Flooring

Remove plywood infill, prepare and level substrate as required, and install a compatible finished material to provide a continuous, uniform finished floor surface.

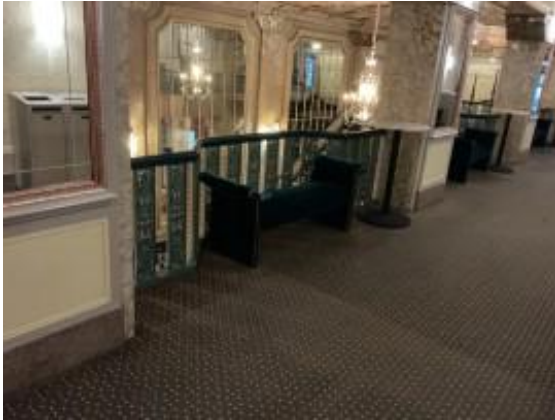
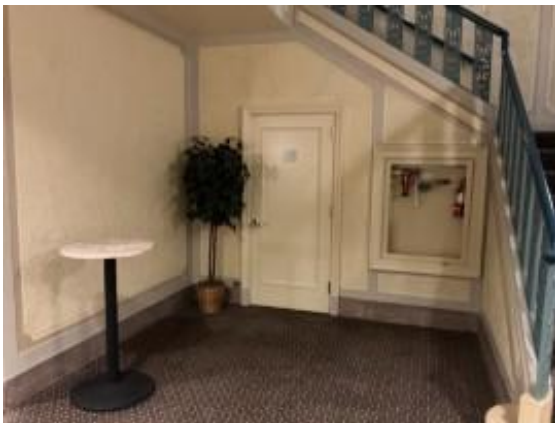
## End of Useful Life: Carpeting

C3225 Carpeting

Replace with new.

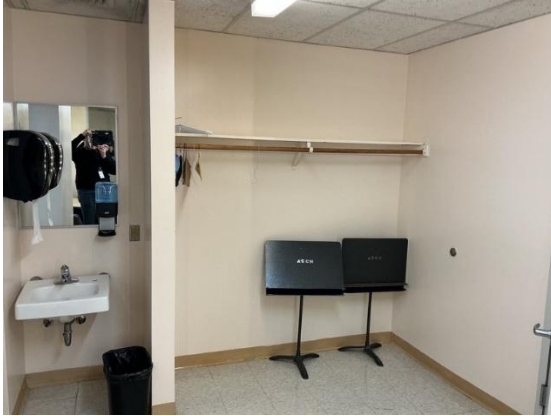
## End of Useful Life: Bases, Curbs and Trim

C3226 Bases, Curbs and Trim

Replace with new.

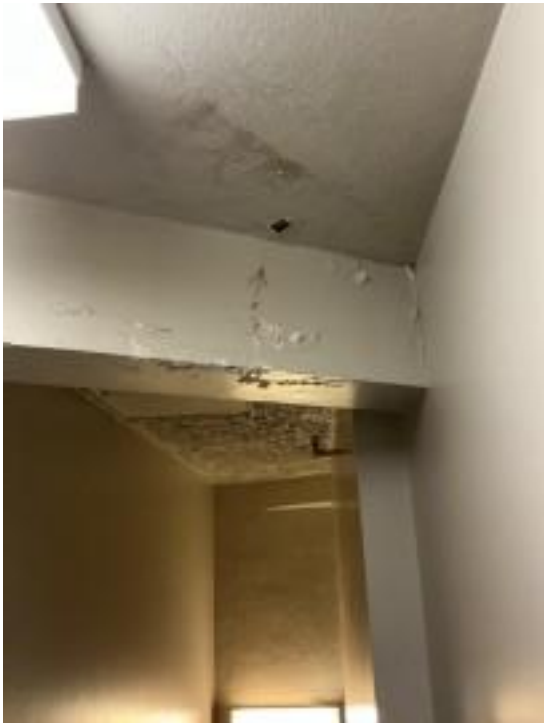
Major Maintenance: Ceiling Finishes

C3331 Ceiling Finishes

Repair damaged ceiling areas, remove loose or compromised material, refinish affected sections, and repaint to match existing. Coordinate with Envelope team to confirm and resolve the moisture source prior to completing repairs.

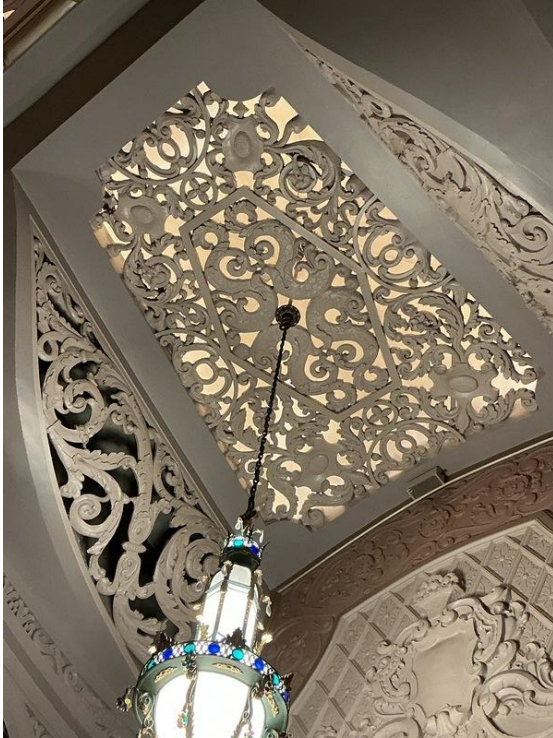
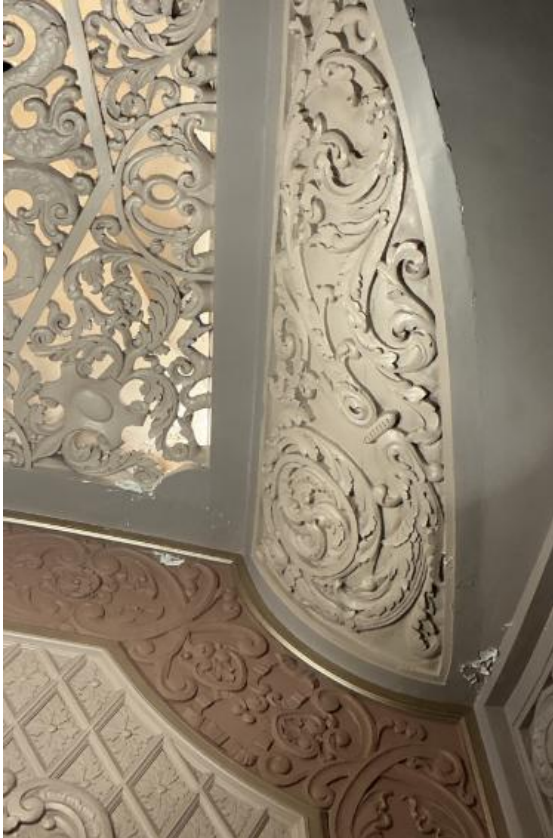
## Major Maintenance: Ceiling Finishes

C3331 Ceiling Finishes

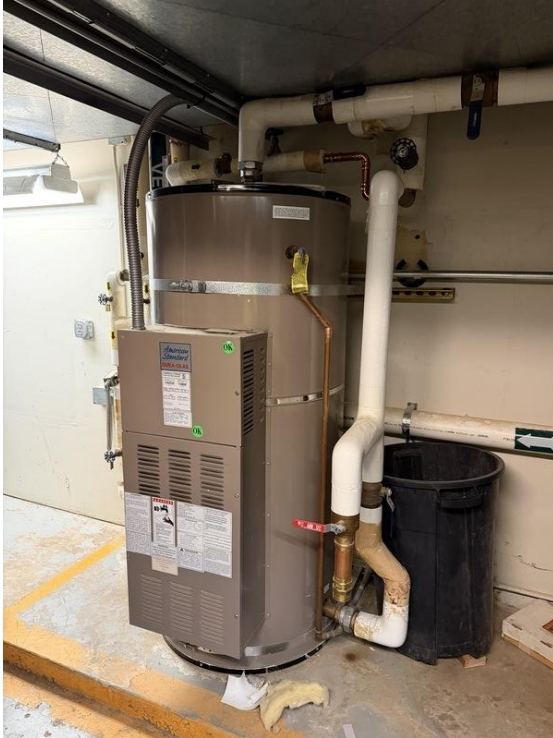
## Additional Evaluation Needed: Domestic Water Supply Equipment

D2223 Domestic Water Supply Equipment

Evaluate options for storage tank or additional hot water capacity. Heat pump water heater with storage tank and electric backup water heater could be a good option. Price reflects evaluation only.

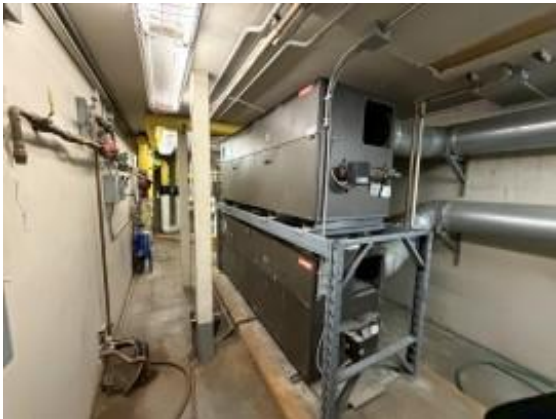
End of Useful Life: Boilers

D3221 Boilers

Replace boilers with newer condensing-style boilers for added system efficiency. Replace expansion tank, boiler room piping, and upgrade pumps to variable speed system at time of replacement. Total Cost includes pricing for these systems.

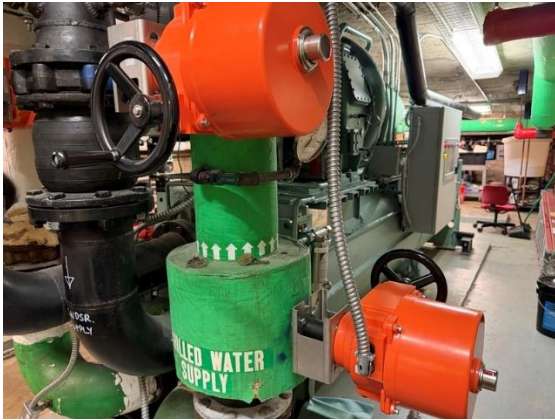
## End of Useful Life: Chilled Water Systems

D3331 Chilled Water Systems

Replace chiller with new modular system.  
Investigate heat recovery chiller options to potentially reduce natural gas load for boilers.  
Replace piping and upgrade pumps to VFD at the time of replacement.

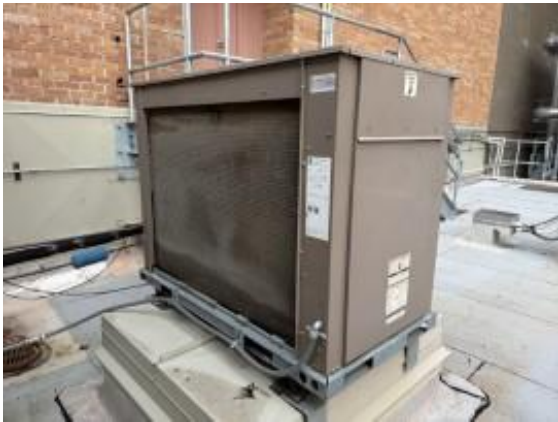
End of Useful Life: Direct Expansion Systems

| D3332 Direct Expansion Systems |

| Replace unit with new equipment. |

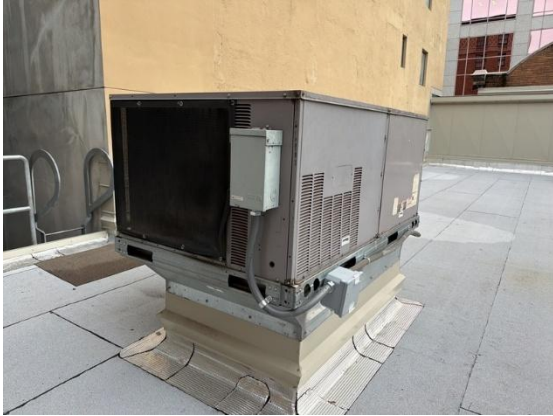
## End of Useful Life: Package Units

D3552 Package Units

Replace with new equipment. Consider adding energy recovery for additional energy savings.

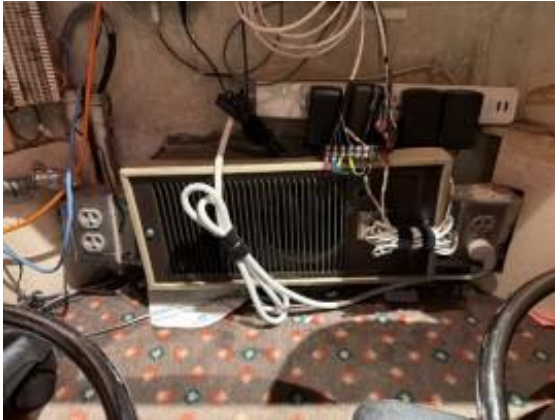
## End of Useful Life: Heating Generating Systems

D3661 Heating Generating Systems

The electric wall heater in the ticket booth is not functional and replacement parts are no longer produced.

Replace unit with new equipment. This may require major renovation in the ticket booth to get new equipment to fit in place.

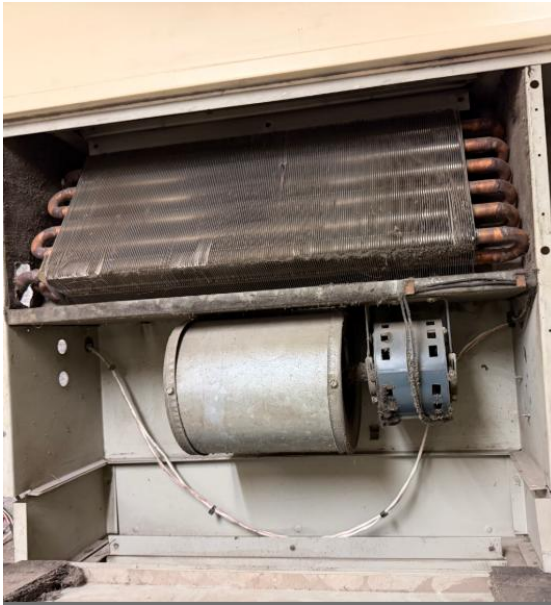
## End of Useful Life: Heating Generating Systems

D3661 Heating Generating Systems

Replace with new heating equipment.

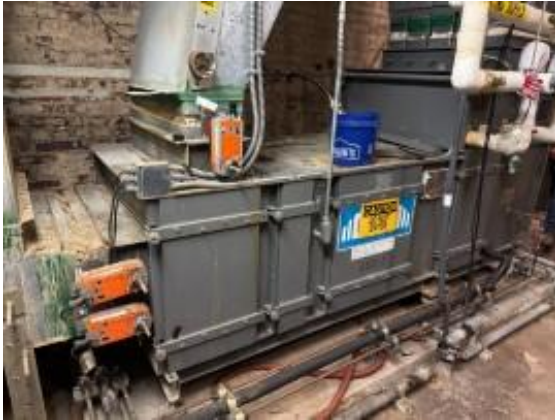
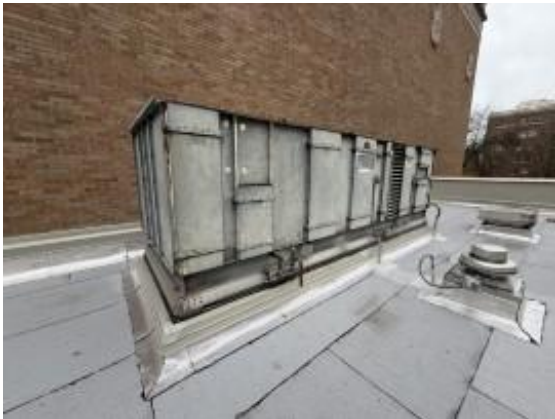
## End of Useful Life: Heating-Cooling Air Handling Units

D3663 Heating-Cooling Air Handling Units

Refurbish unit with new fans, coils, and interior cleaning to extend life of unit. Pricing includes refurbishment of all four units.

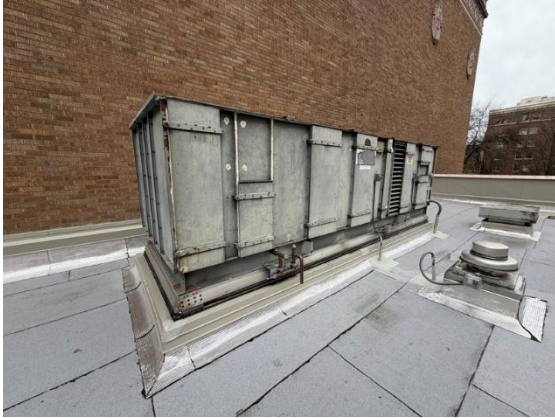
## End of Useful Life: Heating-Cooling Air Handling Units

D3663 Heating-Cooling Air Handling  
Units

Replace unit with a heat recovery ventilator and provide heating and cooling to the space via split-system heat pump in lieu of replacing system in kind.

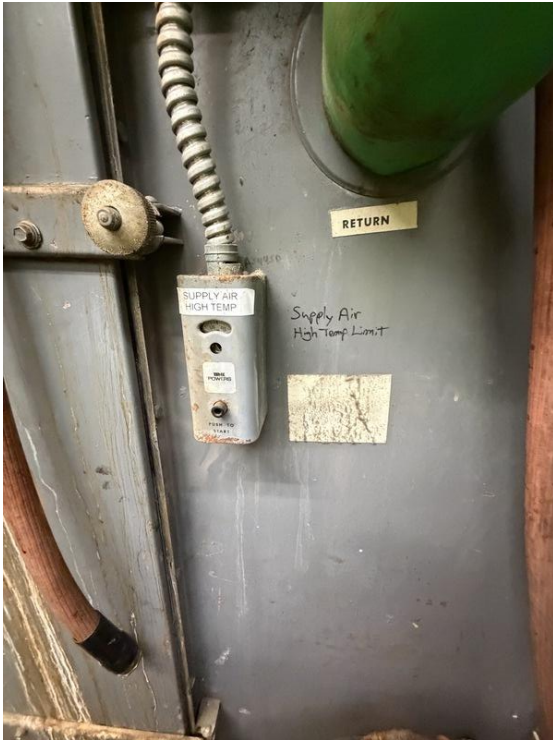
## Additional Evaluation Needed: Other Controls and Instrumentation

D3669 Other Controls and Instrumentation

Perform point to point checkout of sensors, calibration check, and retro-commissioning on entire system. Pricing reflects evaluation only.

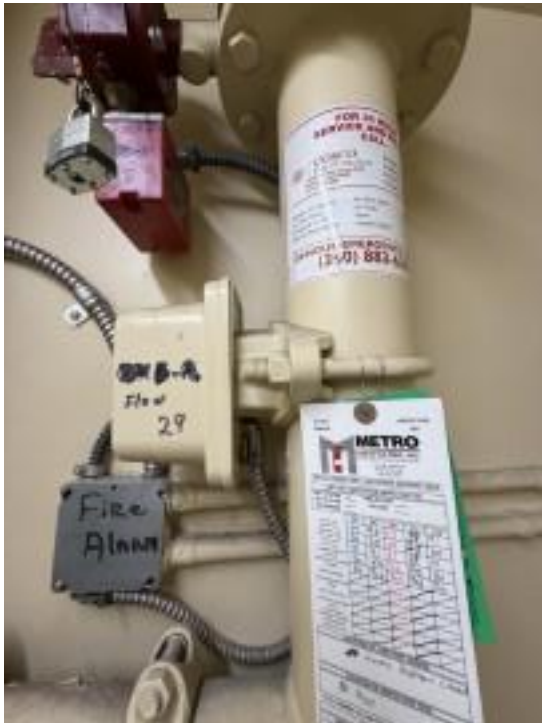
## Additional Evaluation Needed: Wet Sprinkler Systems

D4114 Wet Sprinkler Systems

The fire sprinkler system is at end of useful life. Piping shows signs of rust and controls failures have occurred in the past (flow switches, tampers, etc) with parts that are no longer manufactured.

Perform inspection of fire sprinkler piping to assess overall system condition and identify any needs for piping replacement. Fully upgrade system controls.

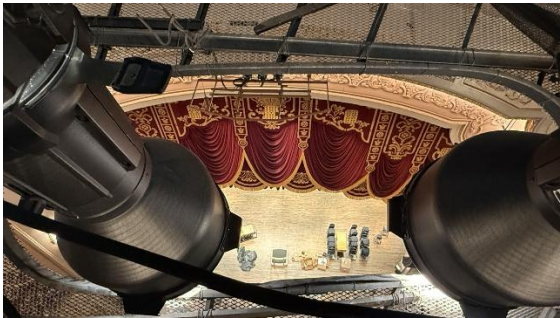
End of Useful Life: Other Special Systems & Devices

| D5994 Other Special Systems & Devices |

| Replace incandescent, fixed focus fixtures in these locations with automated LED profile units. |

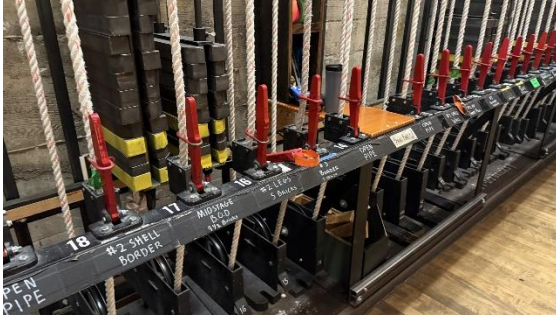
## End of Useful Life: Theater & Stage Equipment

E1223 Theater & Stage Equipment

Existing Manual Stage Rigging has exceeded its useful life. Replacement is currently scheduled for 2026.

Replace stage rigging components that have exceeded manufacturer recommended service life; inspect supporting structure; perform load testing/certification by qualified rigging contractor.

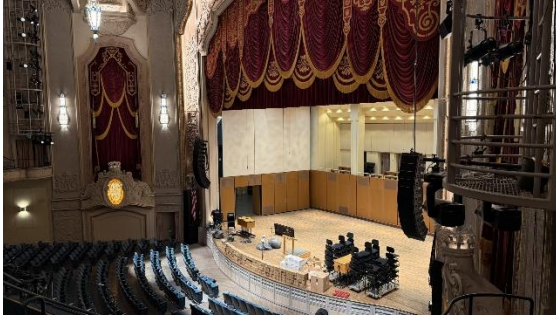
## End of Useful Life: Audio-visual Equipment

E1225 Audio-visual Equipment

Existing Meyer Constellation system in good working order. Existing Meyer line array house PA is in need of replacement.

Replace the existing line array system with a modern, appropriately sized system; integrate with amplification/processing and verify coverage and performance.

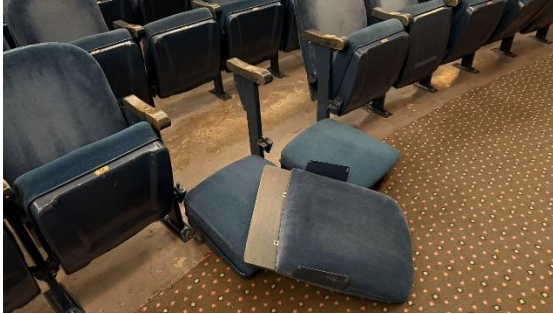
## End of Useful Life: Fixed Multiple Seating

E2115 Fixed Multiple Seating

Fixed seating beyond useful life and in need of replacement.

Replace fixed seating systems that have exceeded useful life; repair substrate/anchorage as required and verify accessibility/aisle clearances. Pricing for this CA does not include ADA upgrades.

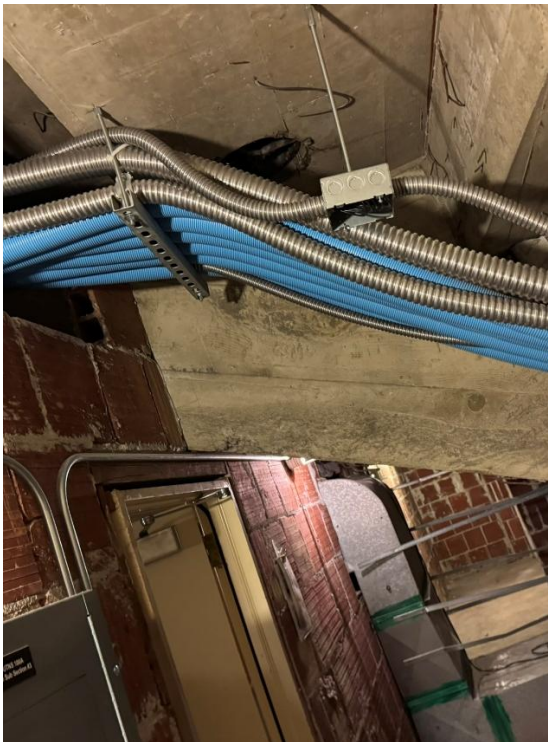
Additional Evaluation Needed: Wiring & Conduits & Ductbanks

*This picture represents typical branch wiring*

| <b>Component</b> | G4223 Wiring & Conduits & Ductbanks |
| <b>Observed Deficiency</b> | Reports from staff note that branch wiring at devices and fixtures are at end of useful life. |

| <b>Recommended Action</b> | Field investigate branch circuit wiring to determine deficiencies. |
