# Metro Portland's Centers for the Arts

## Facility Condition Assessment for Keller Auditorium

April 10, 2026 | Prepared by: Sazän Group

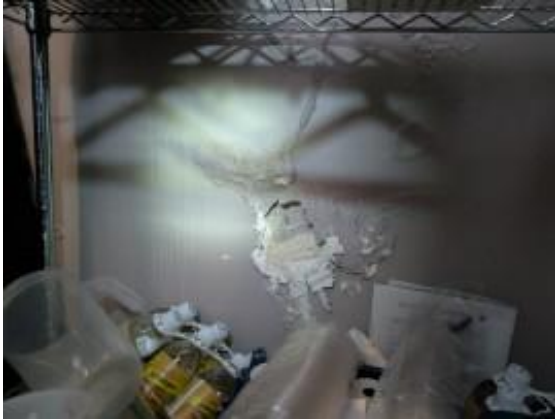
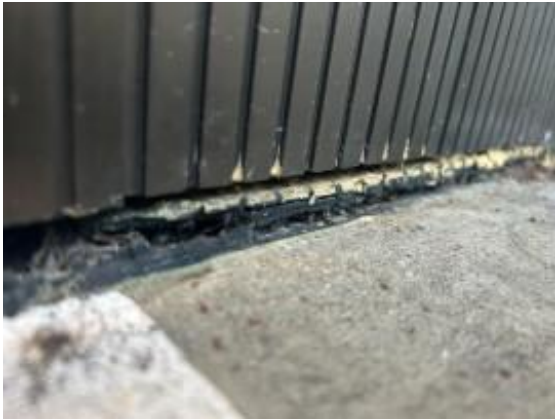
#### End of Useful Life: A1113 Perimeter Drainage & Insulation

A1113 Perimeter Drainage & Insulation

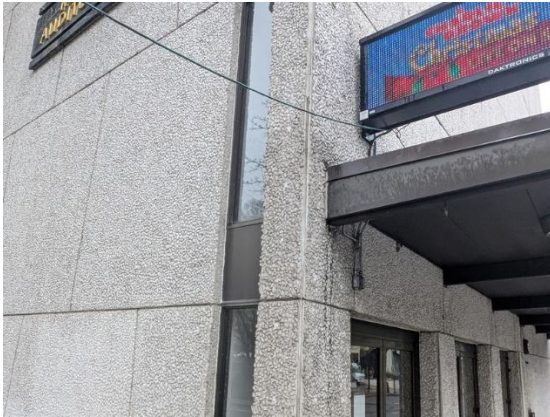
## Additional Evaluation Needed: B1223 Canopies

B1223 Canopies

Develop scope of repair then install and integrate new flashing/ water-resistive barrier at deficient connection. With precast panel cladding having been epoxy bonded to structure, repair feasibility is uncertain. Price reflects cost of evaluation only.

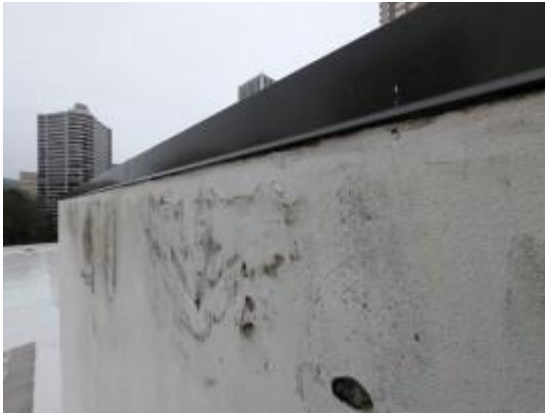
## End of Useful Life: B2111 Exterior Wall Construction

B2111 Exterior Wall Construction

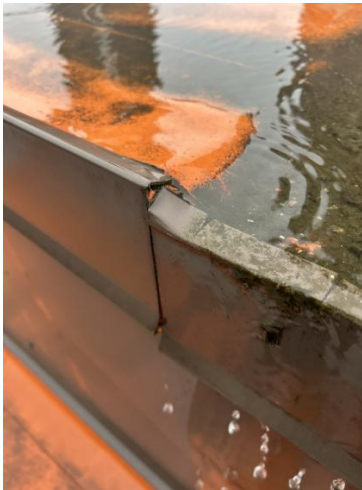
*Separation at flashing joint*

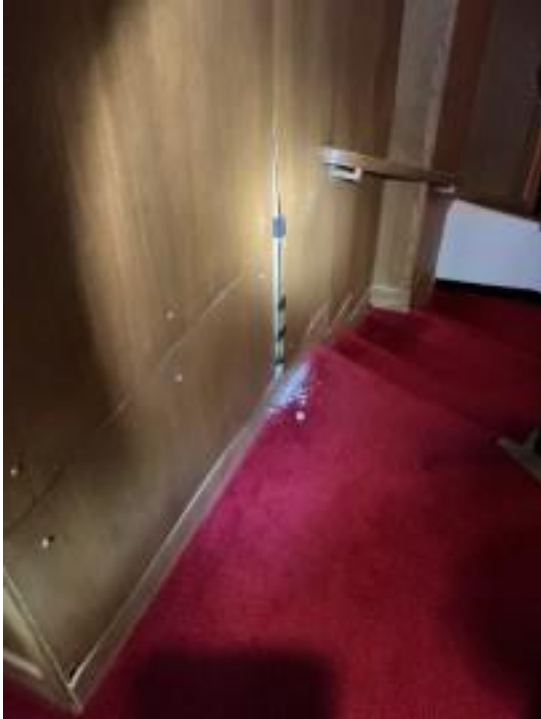
## End of Useful Life: C3112 Wall Finishes to Interior Walls

C3112 Wall Finishes to Interior Walls

Reattach loose veneer panels where feasible and selectively replace panels that cannot be adequately secured.

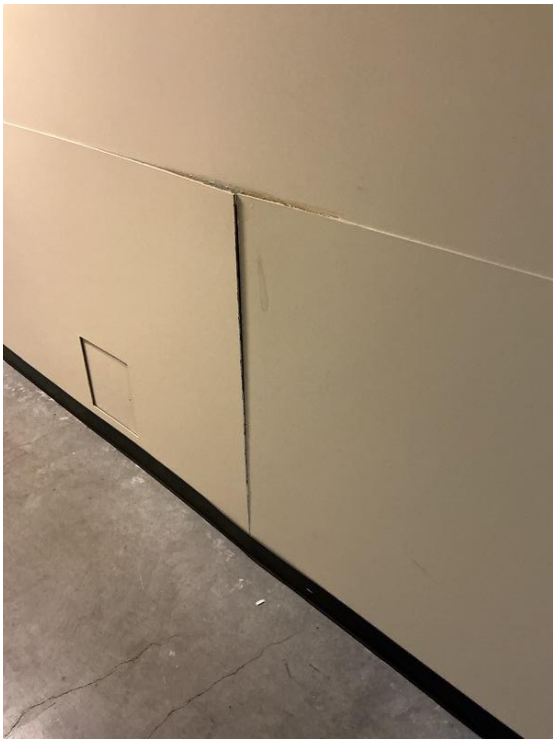
Major Maintenance: C3112 Wall Finishes to Interior Walls

| C3112 Wall Finishes to Interior Walls |

| Re-secure existing wall protection where feasible and replace sections that cannot be adequately fastened. |

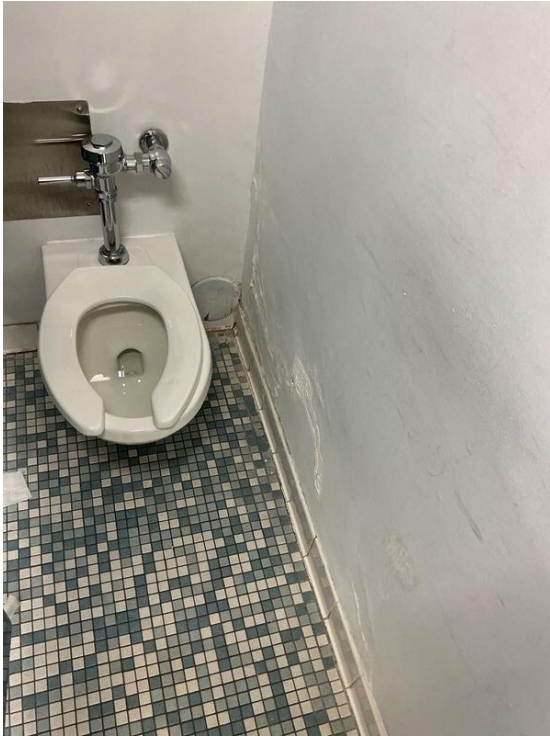
## Major Maintenance: C3112 Wall Finishes to Interior Walls

C3112 Wall Finishes to Interior Walls

Repair damaged wall finishes, address localized moisture impacts as required, and refinish wall surfaces with durable, moisture-resistant coatings appropriate for restroom environments

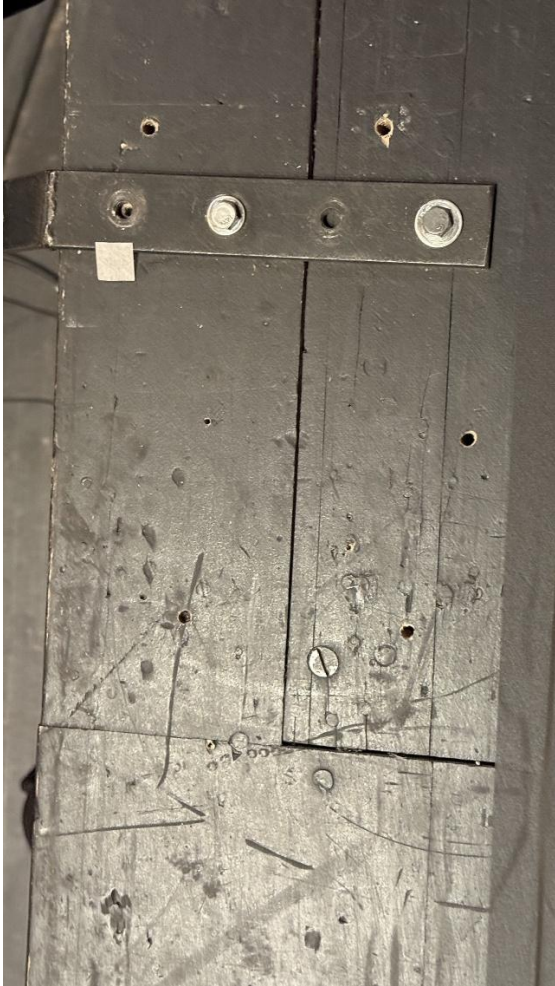
## End of Useful Life: C3224 Flooring

C3224 Flooring

Refinish or replace worn stage flooring panels and finish surfaces; restore resilience/levelness and recoat to manufacturer recommendations.

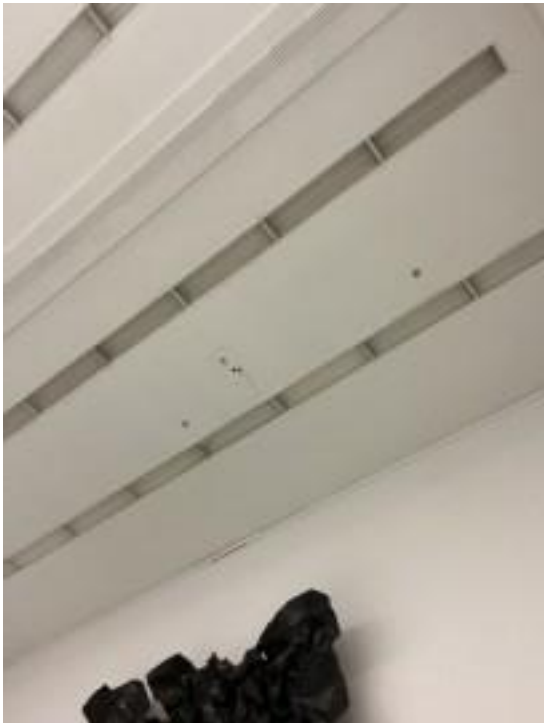
Additional Evaluation Needed: C3331 Ceiling Finishes

C3331 Ceiling Finishes

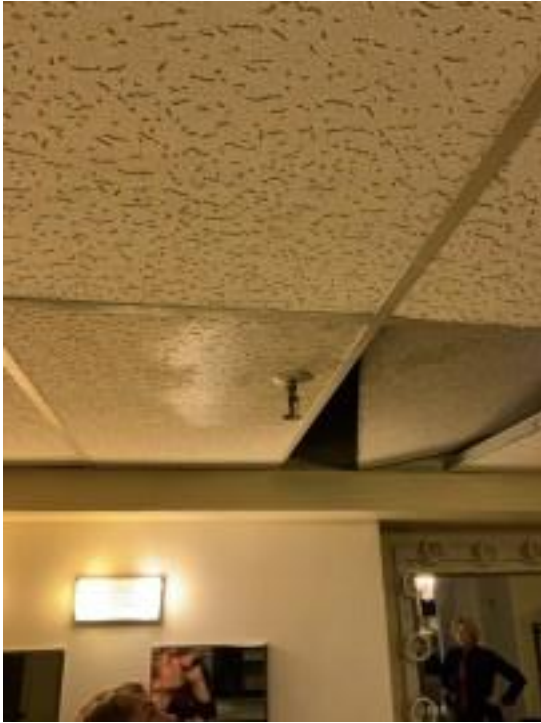
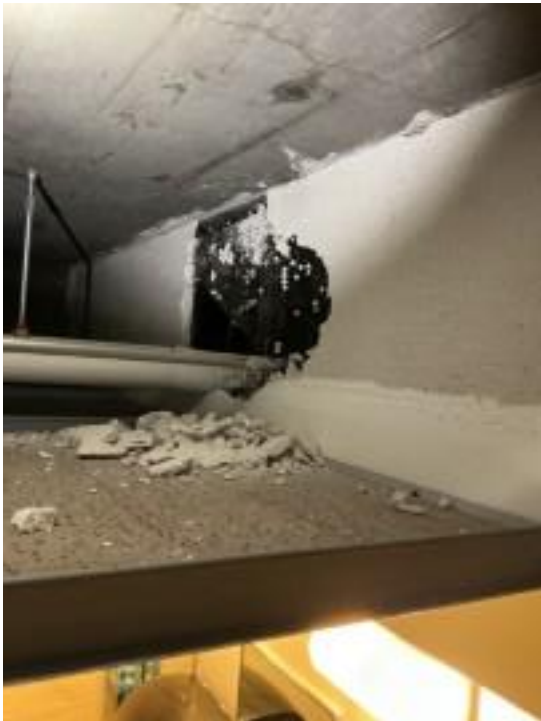
## Additional Evaluation Needed: C3332 Suspended Ceilings

C3332 Suspended Ceilings

Coordinate with the building envelope and/or MEP teams to identify and remediate the source of moisture intrusion above. Replace affected ceiling tiles and repair grid components following resolution of the leak source.

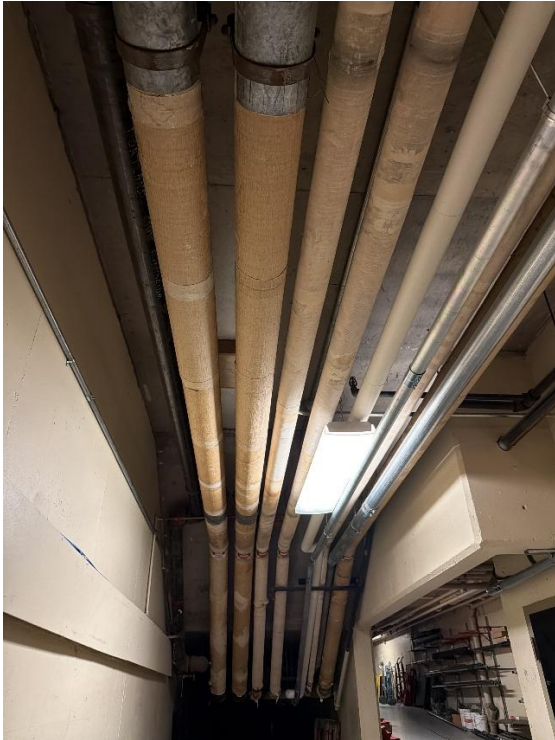
## Major Maintenance: D3224 Insulation

D3224 Insulation

Evaluate all piping to identify areas where insulation has been damaged and may be friable. Remediate and replace any areas that are damaged. Price reflects cost of evaluation only.

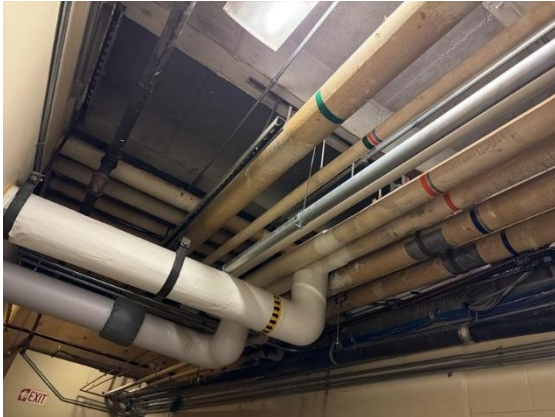
## Major Maintenance: D3444 Hot Water Distribution

D3444 Hot Water Distribution

Remove and replace damaged/deteriorated mechanical pipe insulation; inspect piping during insulation work and replace corroded or compromised sections; recoat and label as required.

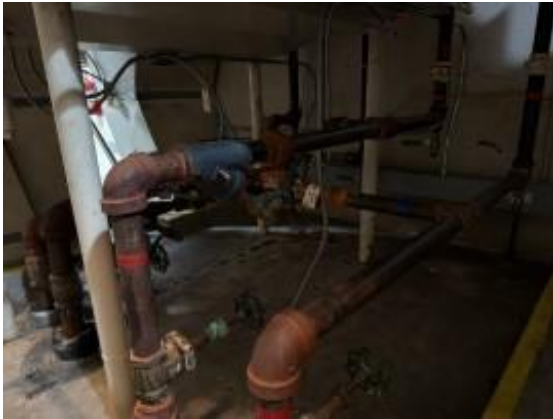
## Major Maintenance: D3663 Heating-Cooling Air Handling Units

D3663 Heating-Cooling Air Handling  
Units

Replace missing insulation.

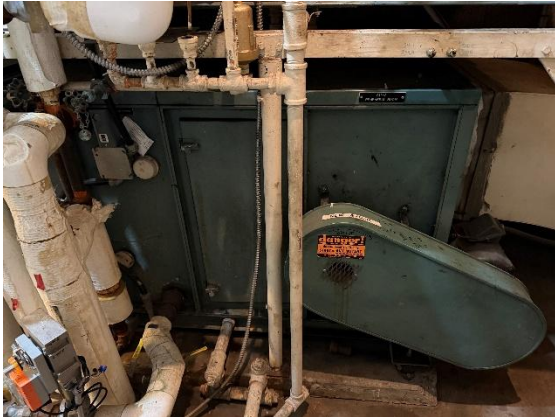
## Major Maintenance: D3772 Air systems Testing & Balancing

D3772 Air systems Testing & Balancing

Perform TAB on the air side of the HVAC system and assess whether system meets current minimum ventilation standards.

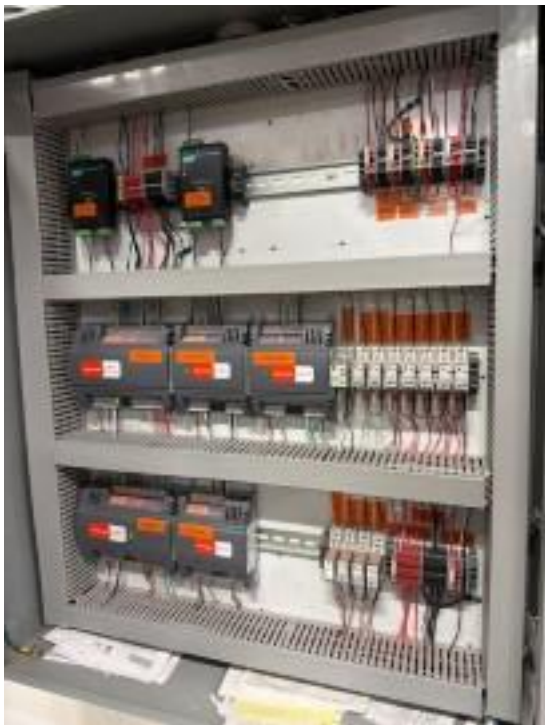
**Additional Evaluation Needed: D3773 HVAC Commissioning**

D3773 HVAC Commissioning

Perform retro-commissioning to assess overall operational efficiency and identify adjustments needed to verify the HVAC system is operating as designed for the building’s remaining service life.

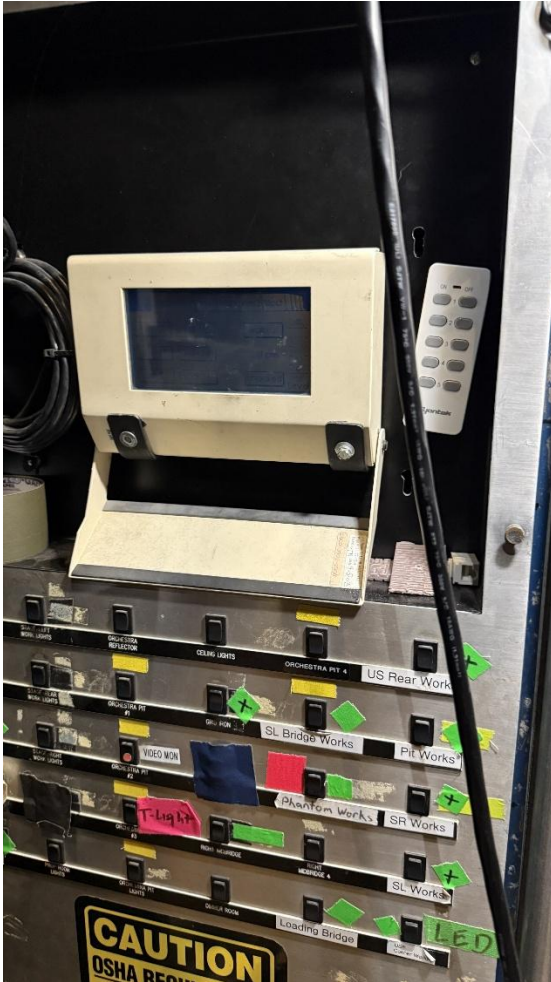
## End of Useful Life: D5223 Lighting Controls

2. Existing House, Work, & Production lighting controls systems are outdated and nearing end of manufacturer's support.  
*Recommendation:* Recommend replacement of new integrated, networked, lighting controls infrastructure with current generation systems.

D5223 Lighting Controls

Replace lighting control and dimming systems (racks, panels, control stations) and integrate with new lighting equipment; test and commission.

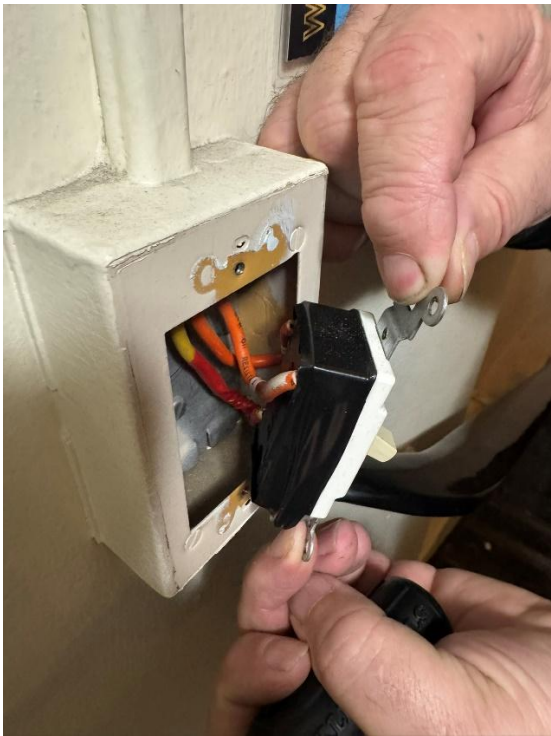
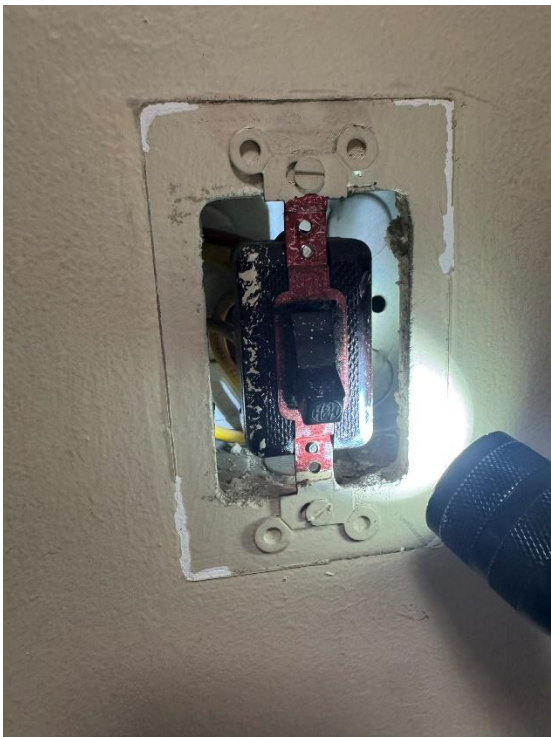
Major Maintenance: D5991 Grounding Systems

D5991 Grounding Systems

Recommendation: Branch circuit wiring and grounding should be further investigated and replaced as required.

More invasive field investigation required to identify deficient locations.

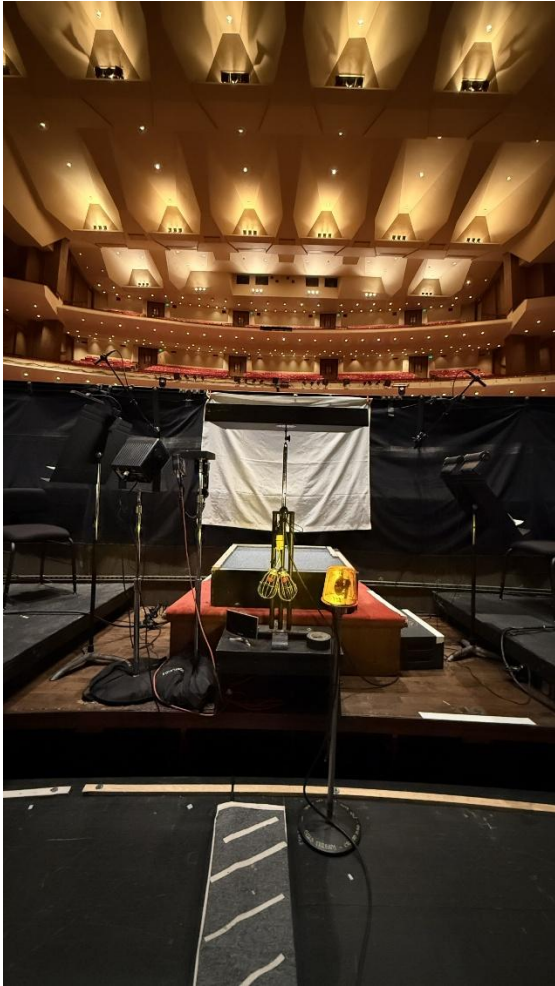
## Life Safety and Code Violation: D5994 Other Special Systems & Devices

1. Existing orchestra pit lift system shows ample evidence that it has exceeded manufacturer's anticipated useful life and does not conform to current ANSI/ESTA standards for motorized orchestra pit lift systems.  
*Recommendation:* Perform a comprehensive inspection and do a major service of lift system.

D5994 Other Special Systems & Devices

Perform a comprehensive inspection and major service of lifts (mechanical, hydraulic, electrical, controls, safety devices); address deficiencies and plan for full replacement when systems reach end of useful life.

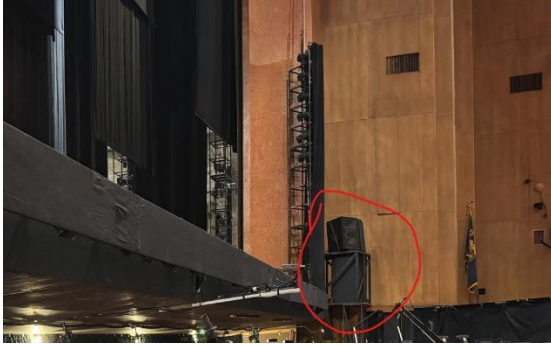
## End of Useful Life: E1225 Audio-visual Equipment

3. The existing house public address speaker system is outdated and underpowered compared to industry standards for similar performance venues.  
*Recommendation:* Replace PA speakers and upgrade the audio reinforcement system (amplification, processing, and signal distribution) to meet current performance needs; test and commission after installation.

E1225 Audio-visual Equipment

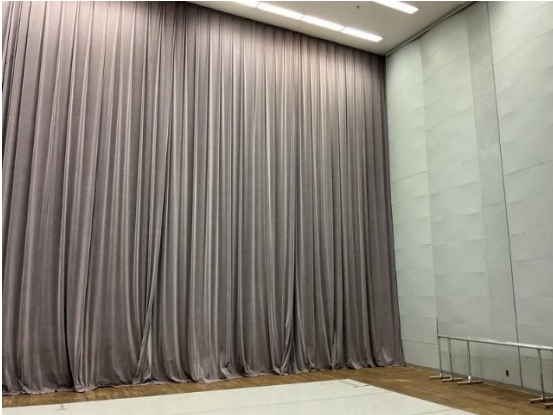
## End of Useful Life: E2223 Movable Rugs and Mats

E2223 Movable Rugs and Mats

Replace worn/torn portable draperies and associated hardware/tracks; clean or dispose of unsalvageable materials and verify fire-rating requirements.

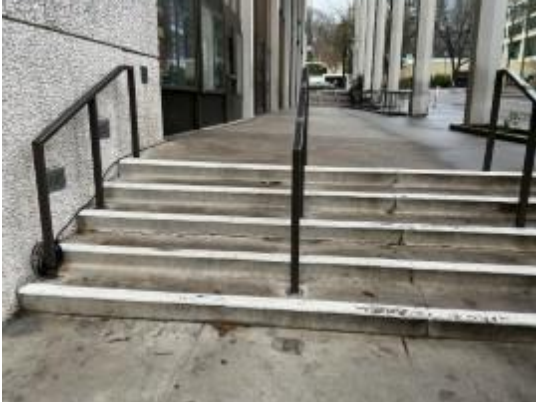
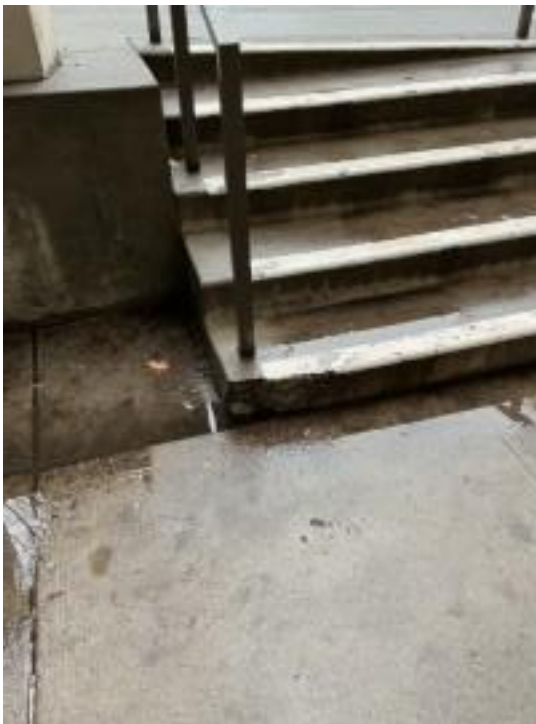
## Life Safety and Code Violation: G2333 Exterior Steps

G2333 Exterior Steps
