# Metro Portland'5 Centers for the Arts

Facility Condition Assessment for  
Antoinette Hatfield Hall

April 10, 2026 | Prepared by: Sazän Group

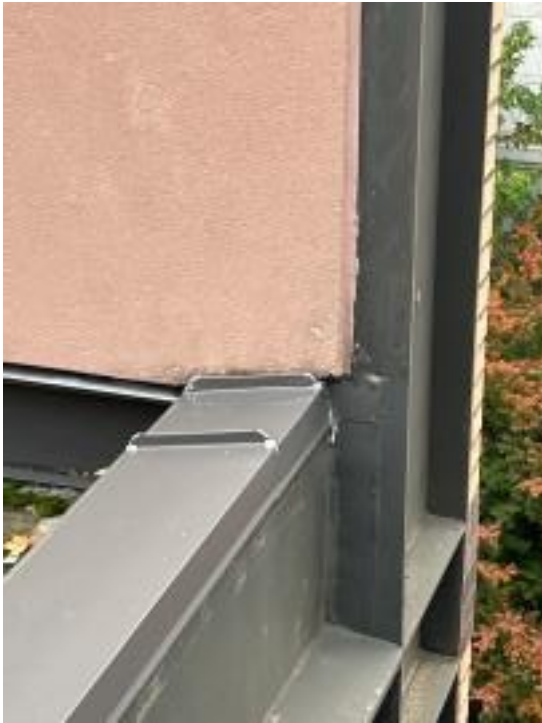
## End of Useful Life: Parapets

B2112 Parapets

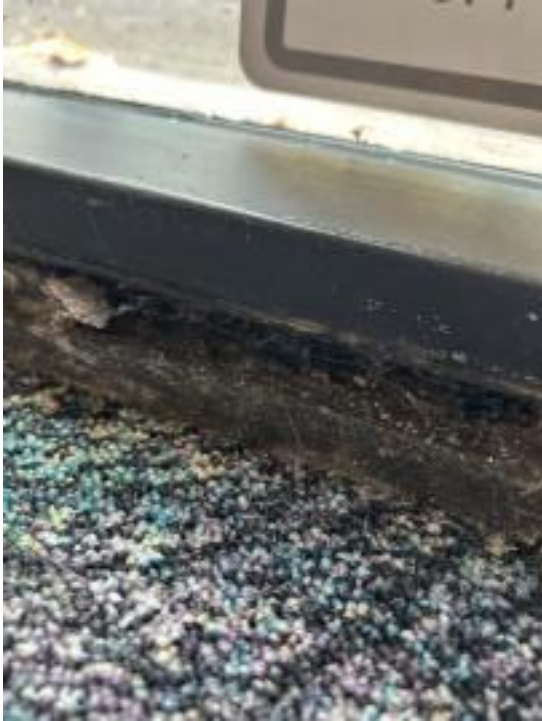
## End of Useful Life: Exterior Storefronts

B2223 Exterior Storefronts

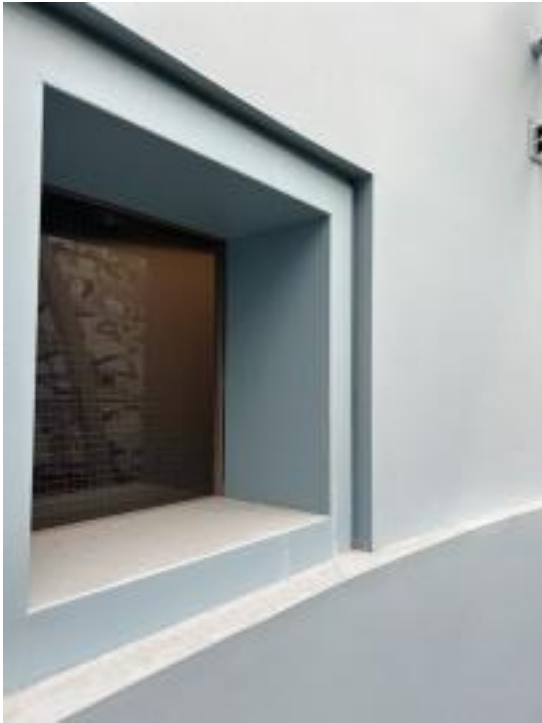
## Additional Evaluation Needed: Glazed Roof Openings

B3221 Glazed Roof Openings

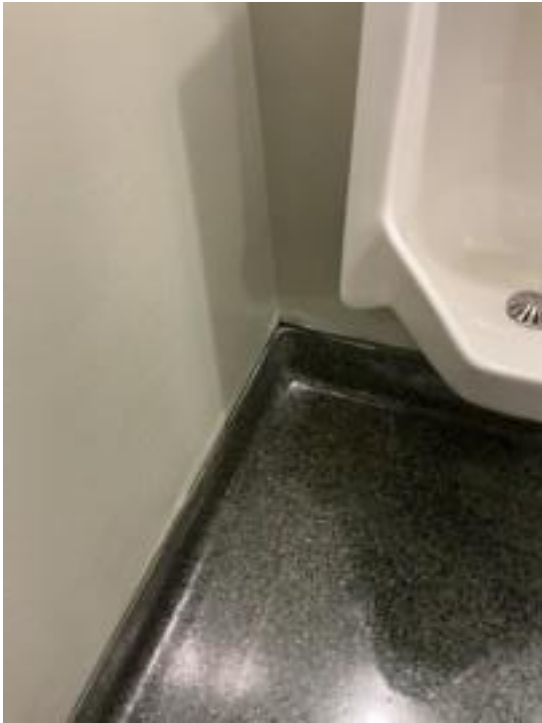
## Major Maintenance: Wall Finishes to Interior Walls

C3112 Wall Finishes to Interior Walls

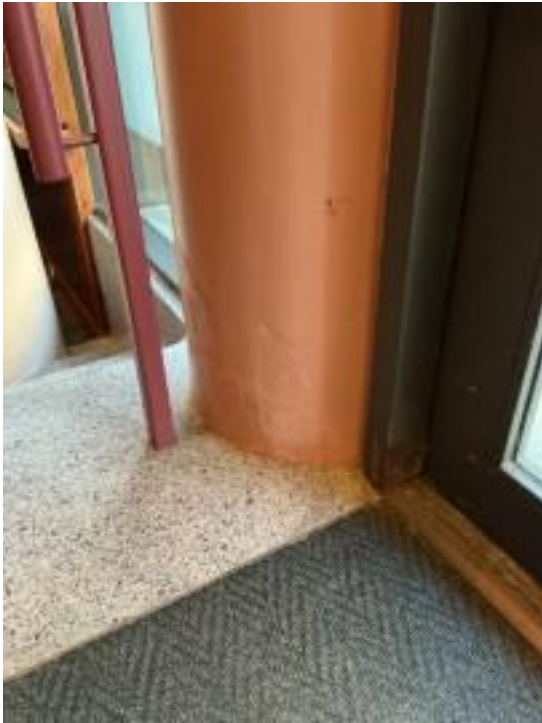
## Major Maintenance: Column Finishes

C3113 Column Finishes

Reapply concrete hardener/sealer to restore surface protection and durability.

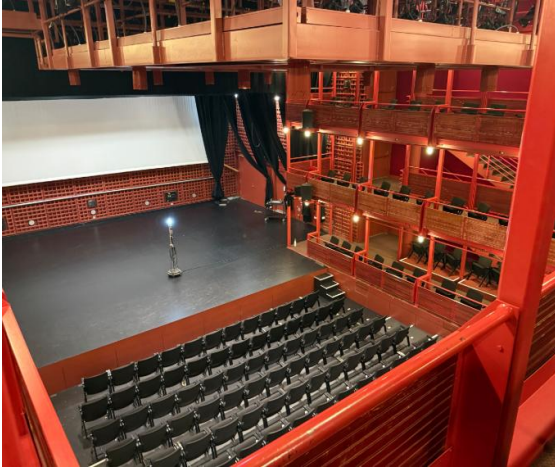
## Major Maintenance: Flooring

C3224 Flooring

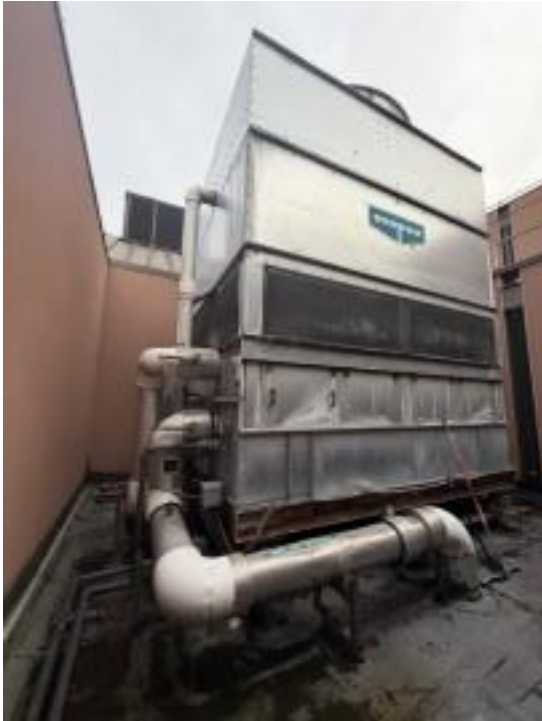
## End of Useful Life: Chilled Water Systems

D3331 Chilled Water Systems

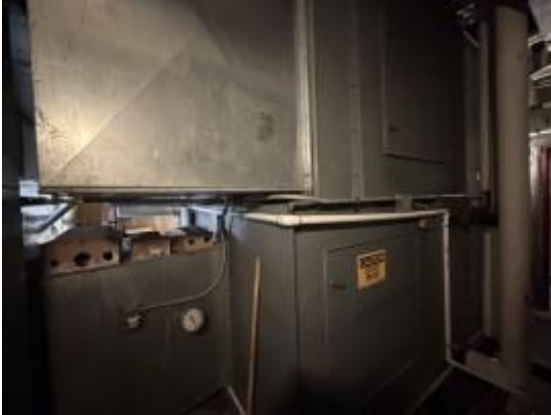
## Major Maintenance: Heating-Cooling Air Handling Units

D3663 Heating-Cooling Air Handling  
Units

Continue with refurbishment of unit by cleaning interior and replacing coils to extend the useful life of the unit. Also investigate addition of a VFD to control the large motor in place of utilizing a large and small motor to control fan speed. Price reflects continued refurbishment costs.

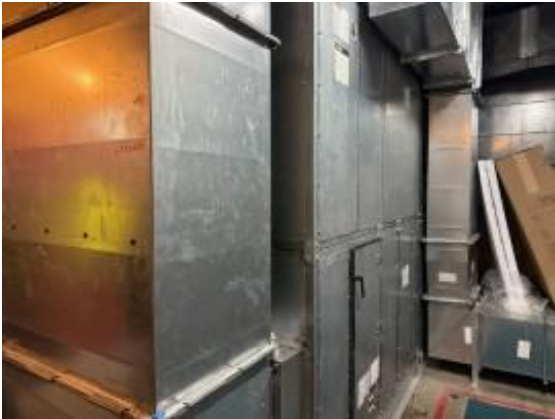
End of Useful Life: Heating-Cooling Air Handling Units

| D3663 Heating-Cooling Air Handling Units |

| Refurbish unit with new fan motors, VFD, coils, and interior clean. |

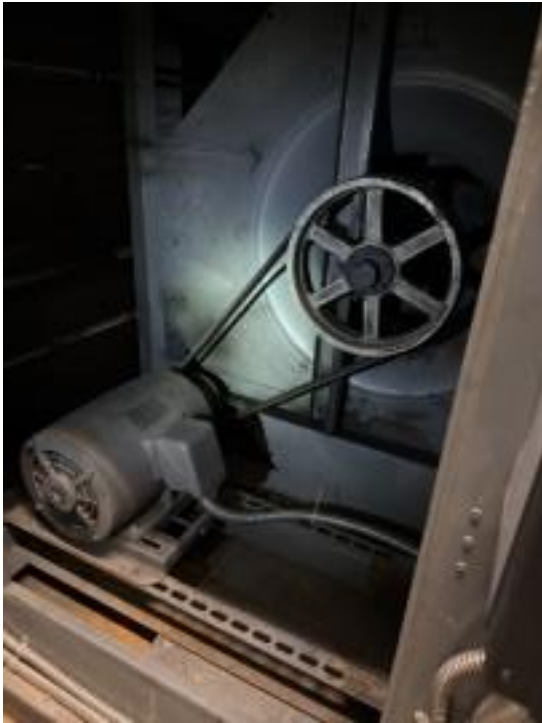
## End of Useful Life: Heating-Cooling Air Handling Units

D3663 Heating-Cooling Air Handling  
Units

Refurbish unit with new fan motors, VFD, coils,  
and interior clean.

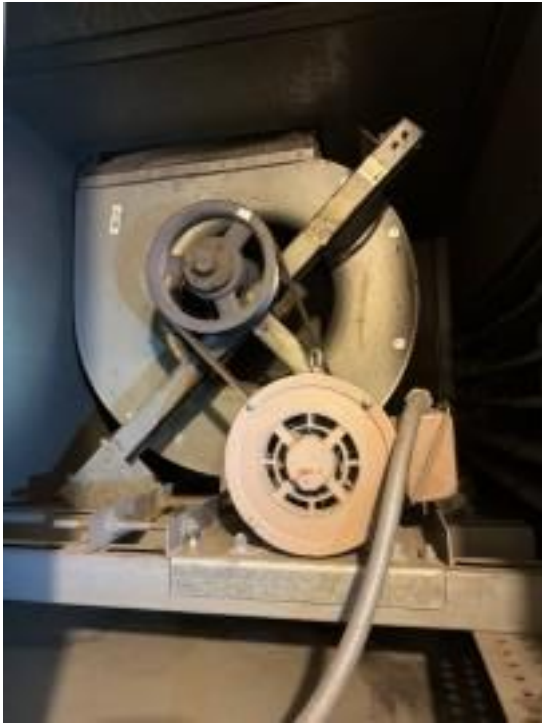
## End of Useful Life: Heating-Cooling Air Handling Units

D3663 Heating-Cooling Air Handling  
Units

Refurbish unit with new fan motors, VFD, coils,  
and interior clean.

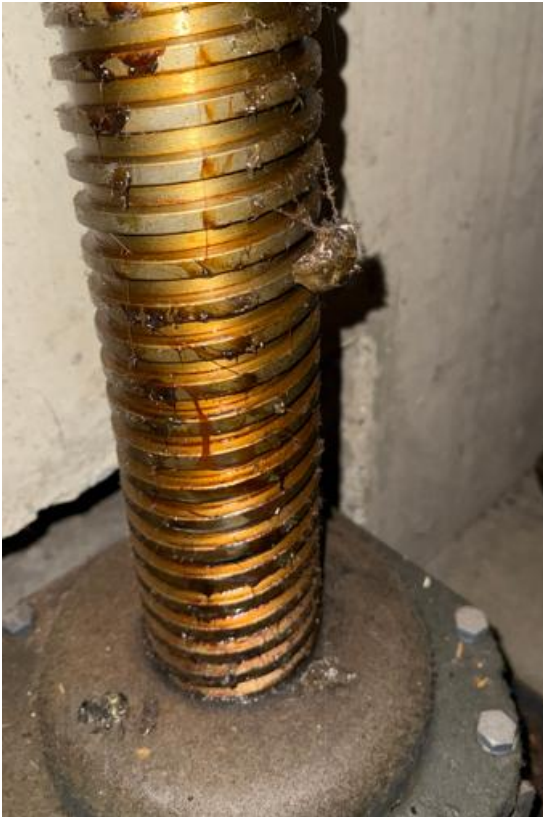
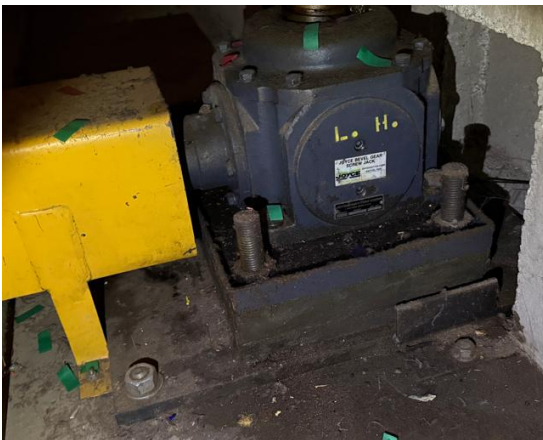
## End of Useful Life: Other Special Systems & Devices

D5994 Other Special Systems & Devices

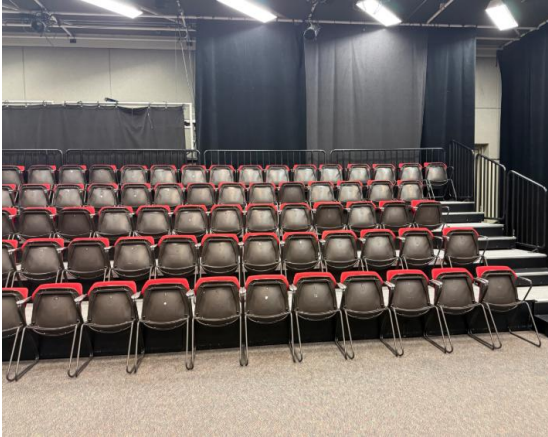
## End of Useful Life: Furniture & Accessories

E2222 Furniture & Accessories
